**UPDATE GEOLOGIC AND GEOTECHNICAL STUDY
PROPOSED RESIDENTIAL DEVELOPMENT**

COGGINS PROPERTY

APN 083-310-150

28 November 2016
Document Id. 00514U-02R1

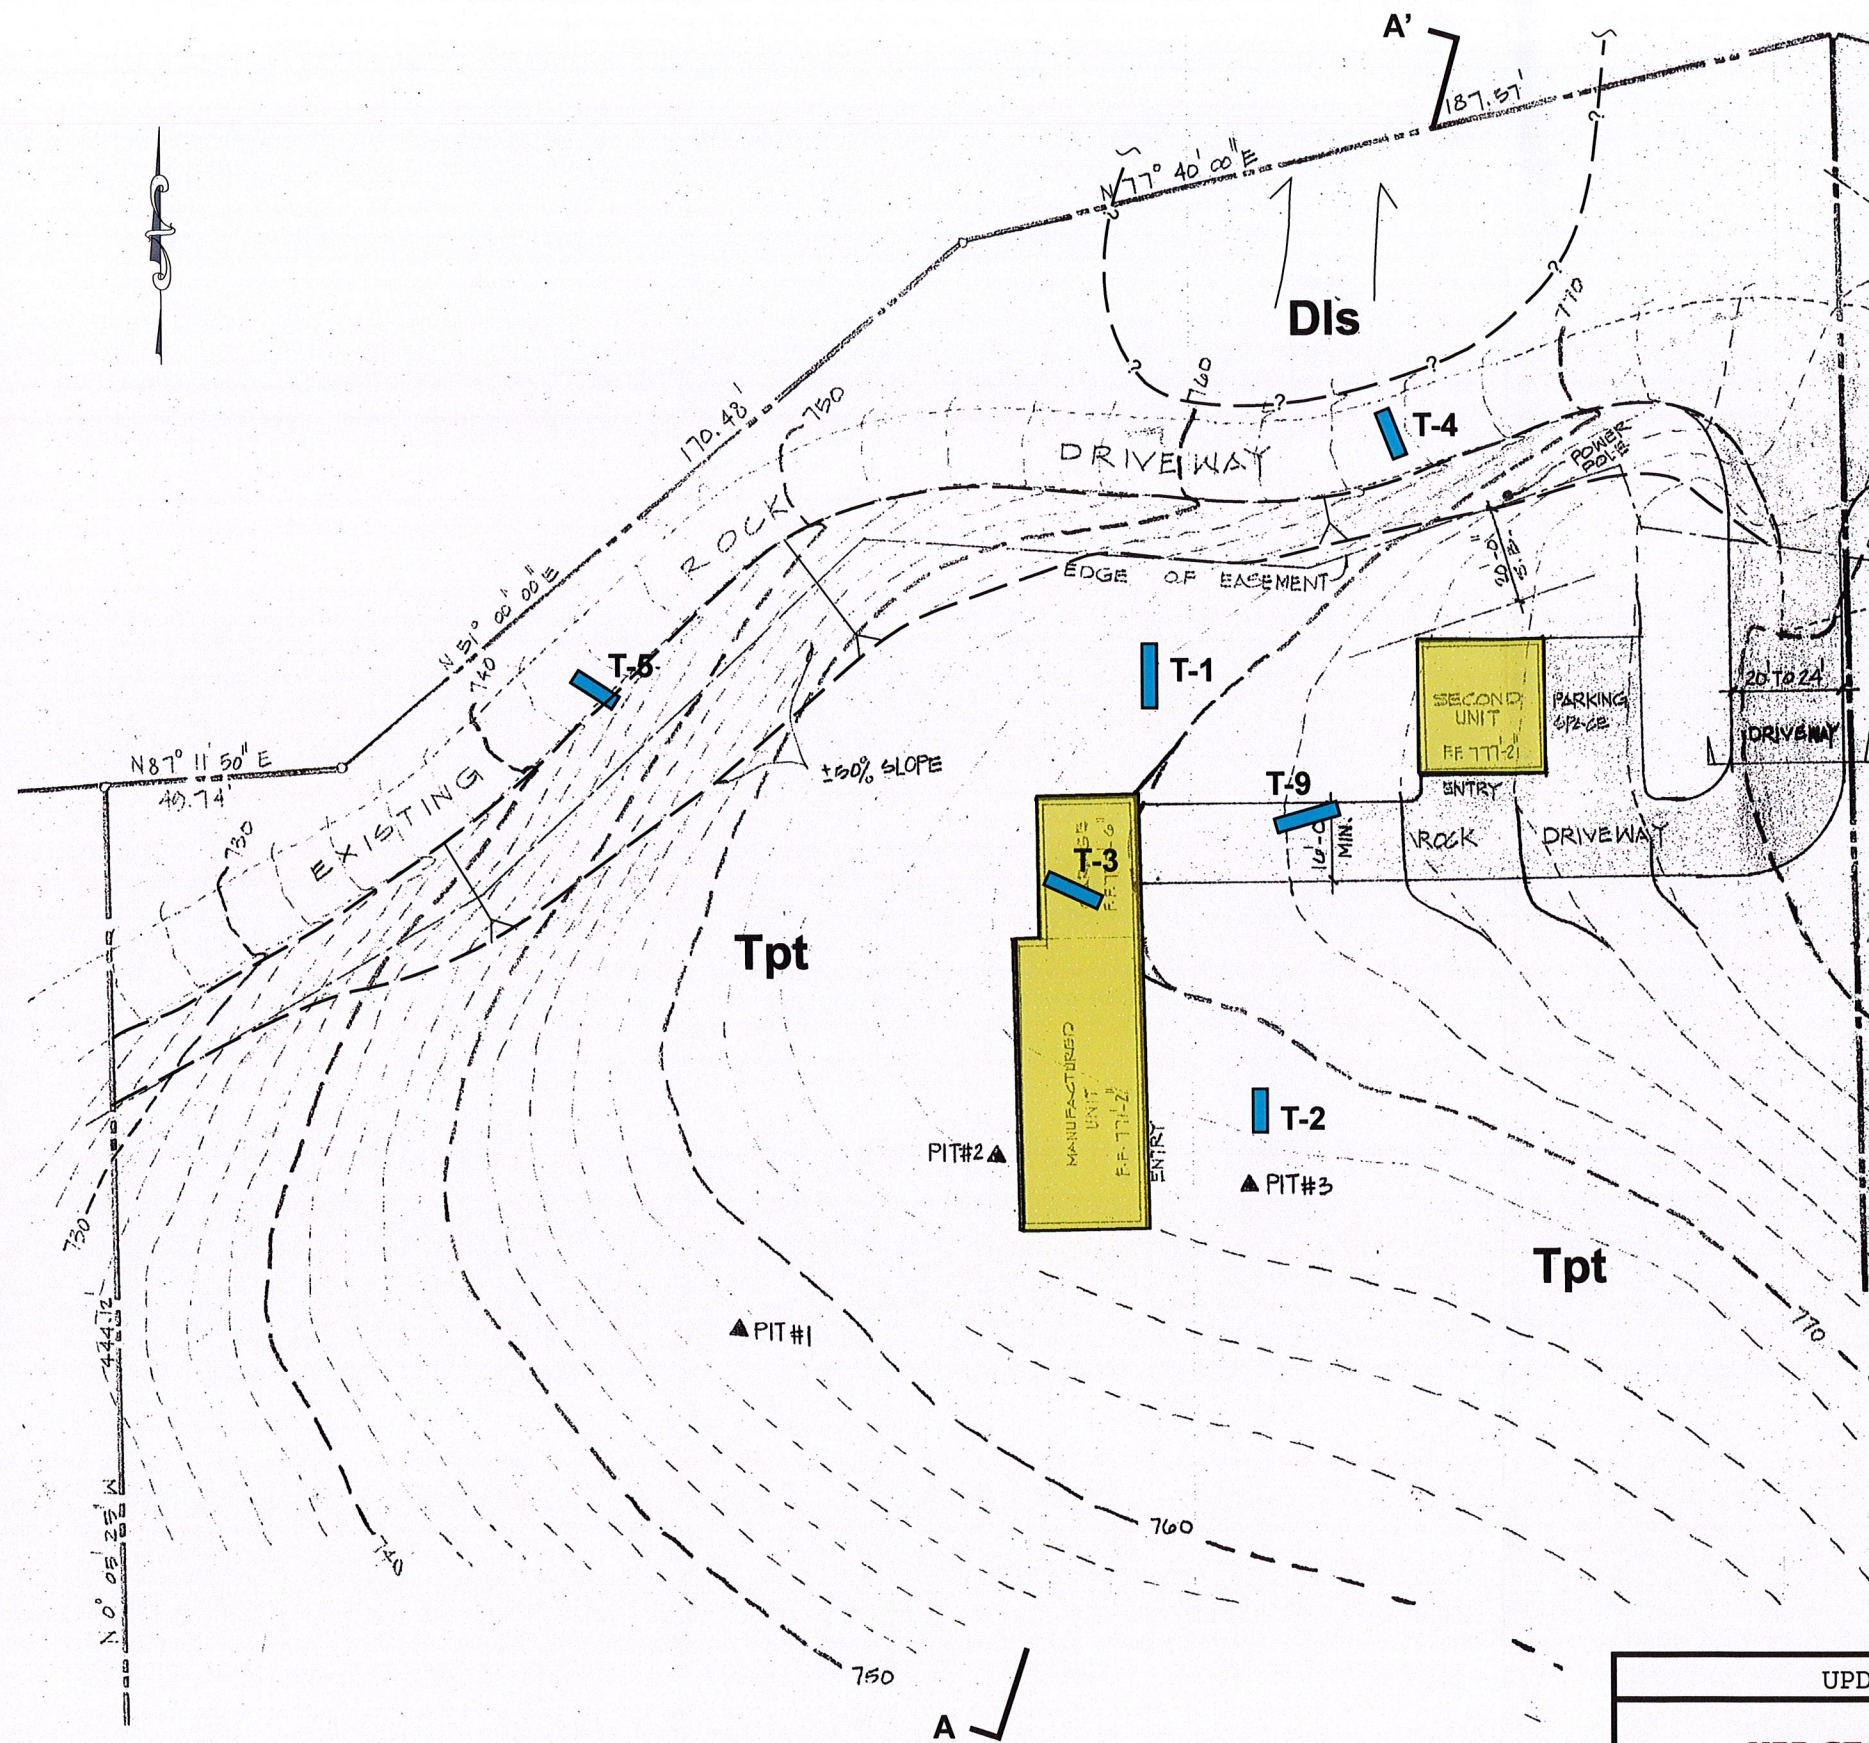
UPDATED PARTIAL SITE PLAN AND ENGINEERING GEOLOGIC MAP				
UPP GEOTECHNOLOGY a division of C2EARTH, INC.		COGGINS PROPERTY APN 083-310-150 San Mateo County, California		
DRAFTED/REVIEWED	SCALE	DOCUMENT ID.	DATE	Figure 4
JB/CH	As Shown	00514U-02R1	November 2016

During our prior study, we observed a relatively small landslide on the slope descending from the north side of the shared driveway down to Coggins Road, north of the subject parcel (see Figure 4). The upper limit of the landslide is about 55 feet northwest of the closest corner of the proposed secondary dwelling and about 83 feet northeast of the nearest corner of the proposed residence and garage. Based on site topography and geomorphology, we judge this landslide to be shallow (less than 10 feet thick) and confined to the surficial soil and colluvium mantling the bedrock at the site

- ***Are existing landslides, active or inactive, present on, or adjacent (either uphill or downhill) to the project site?*** As described above, a shallow, small landslide was previously identified in the northern portion of the site, north of Coggins Road. Based on site geomorphology, we judge the landslide to be shallow and confined to surficial soil and colluvium mantling the bedrock. The shallow soil deformation is greater than 50 feet from any proposed structure. We observed no evidence of slope instability associated with bedrock materials along the crest of the ridge or site vicinity.

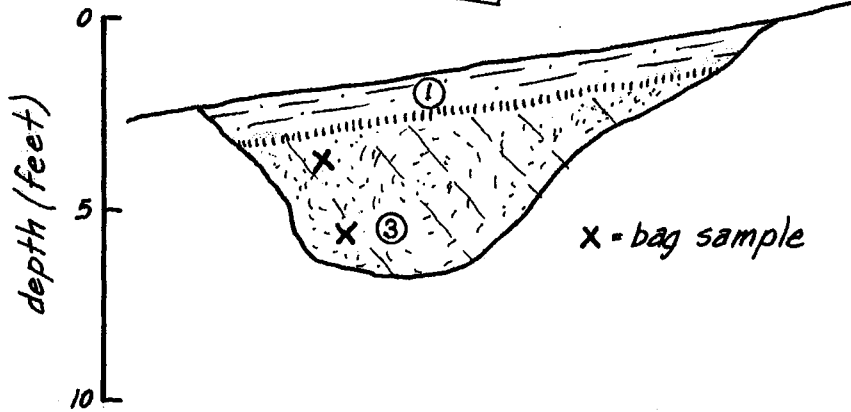
T-4

We previously performed laboratory testing as part of our evaluation of the geotechnical engineering properties of the soil and bedrock at the site. We retained soil and rock samples from the exploration trenches for laboratory classification and testing. The results of moisture content, dry density, shear strength, and plasticity index tests are provided in Appendix A. The plasticity index test performed on a sample of the colluvium retained from Trench 4 revealed the material to be highly expansive, with a plasticity index of 35.

1. **SILTY CLAY (CH)**, slightly moist, dark greyish brown, trace very coarse sand, some roots and rootlets, highly plastic, firm to stiff (Topsoil)
2. **SANDSTONE**, moist, light grey, fine grain, fractures filled with brown clay, manganese oxide staining on fracture surfaces, some iron oxide stains, mostly massive, some fine lamination, medium hardness (Bedrock)
3. **SILTY CLAY (CH)**, moist, dark brown, minor coarse sand, trace roots, disseminated caliche below 3.5', highly plastic, very stiff to hard (Soil/Colluvium)
