Type of Services	Updated Geotechnical Investigation
Project Name	Highland Estates Lots 5 through 11
Location	Ticonderoga Drive/Cobblehill Place/Cowpens Way San Mateo, California
Client	Ticonderoga Partners, LLC.
Client Address	655 Skyway, Suite 230 San Carlos, California
Project Number	230-1-5
Date	October 30, 2015

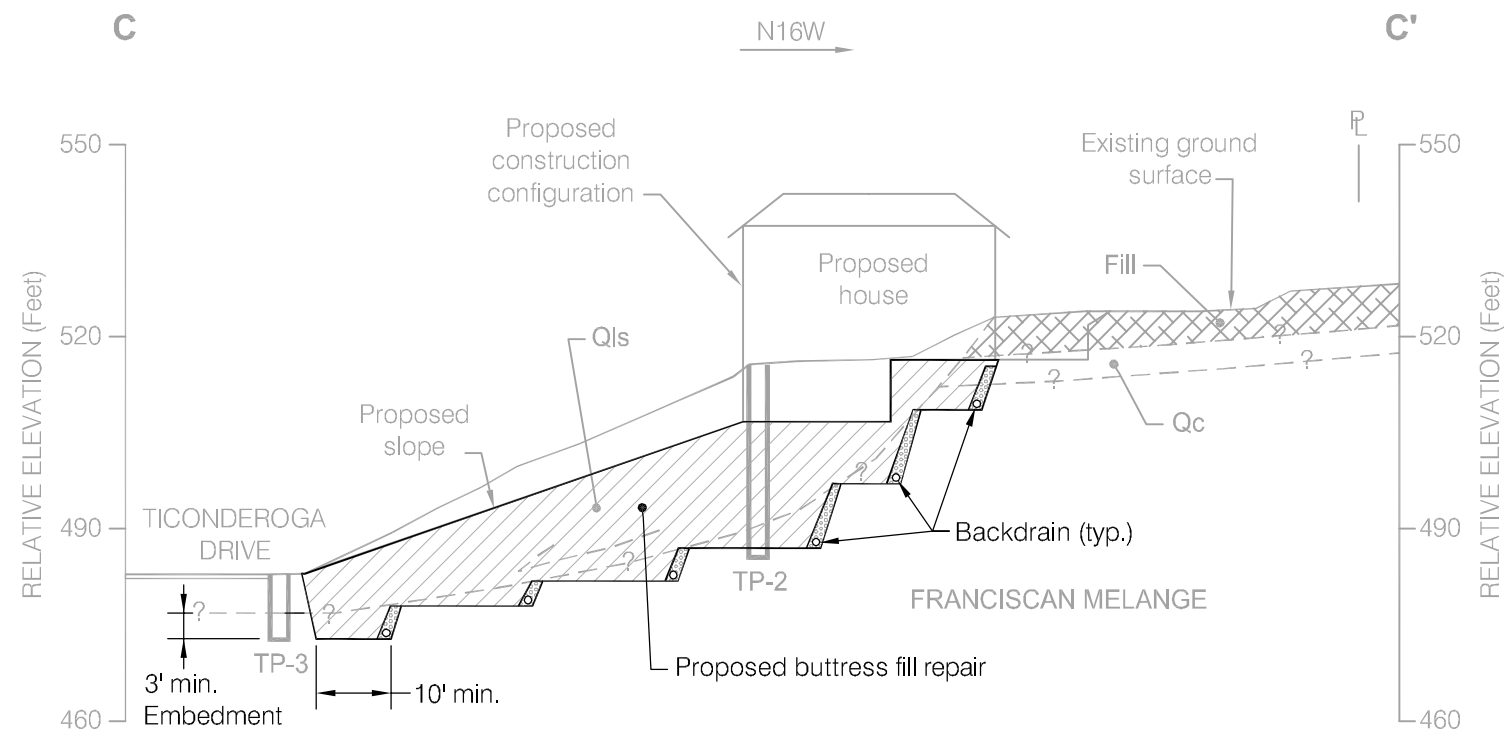
HIGHLAND ESTATES San Mateo County, California		
PROPOSED BUTTRESS FILL REPAIR SUBSURFACE PROFILE		
Date 08/18/09	Project No. 4872.02	Figure C-1
Treadwell&Rollo

The stability of a buttress fill repair for the landslide at Lot 7 and 8 was evaluated along the idealized Geologic Cross-Section C-C' (similar to our current Cross-Section B-B'), which was

determined by Treadwell and Rollo’s engineering geologist to be the most critical slope from a topographic standpoint as well as appropriately modeling the apparent landslide movement observed in their test pits. A simplified two-dimensional model of the landslide and bedrock profile and a typical buttress fill repair consisting of benches and a keyway cut into the Franciscan bedrock below the existing landslide was developed. The keyway extended 3 feet below the bottom of landslide and the keyway and bench widths were at least 10 feet.

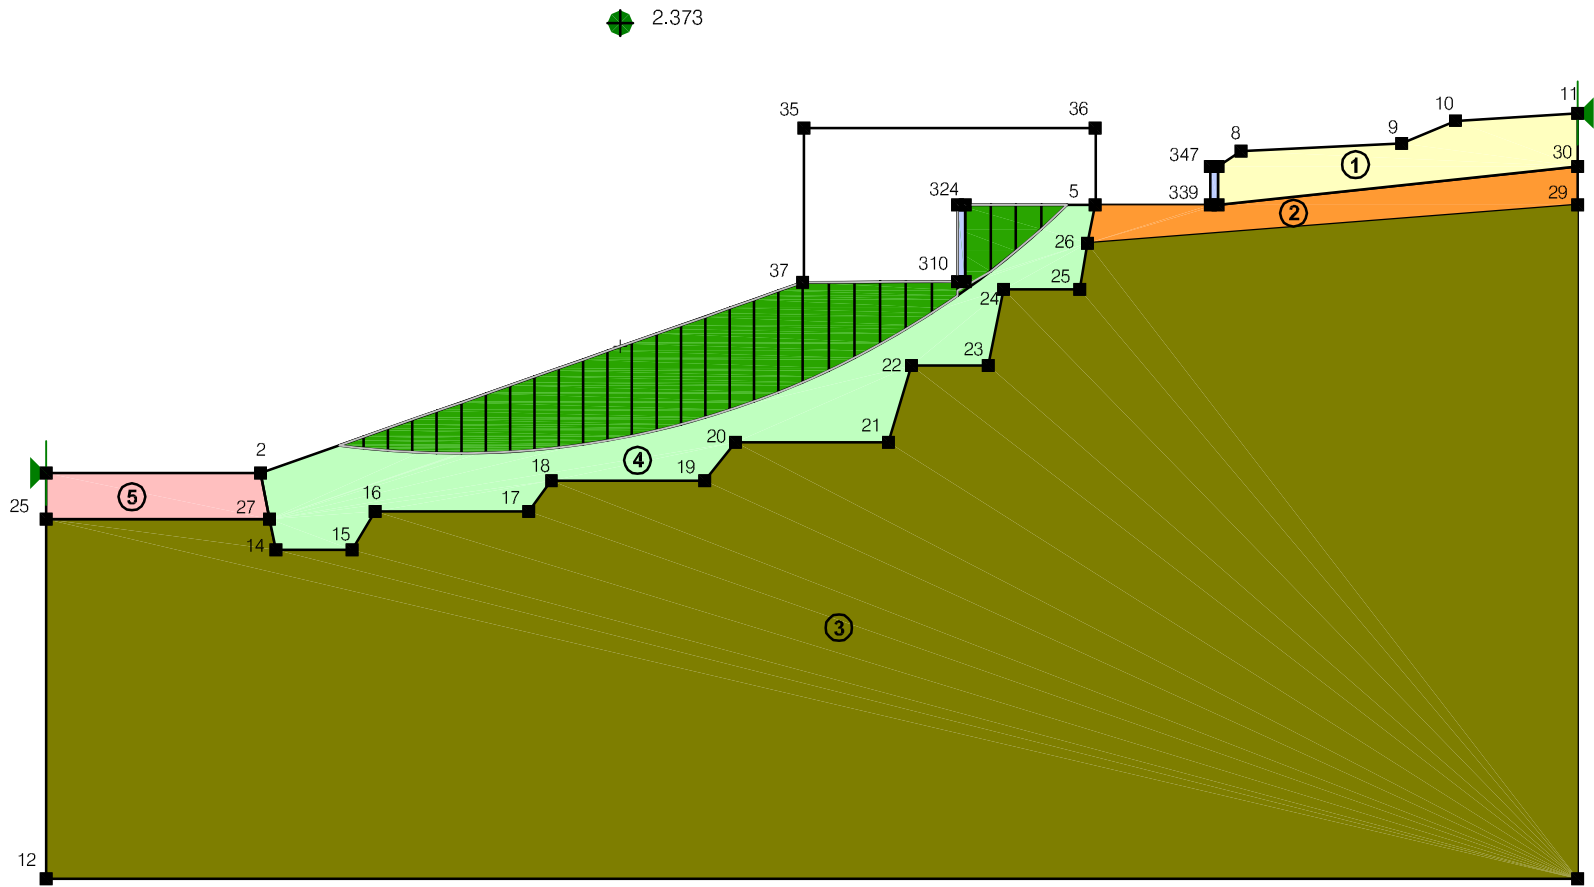
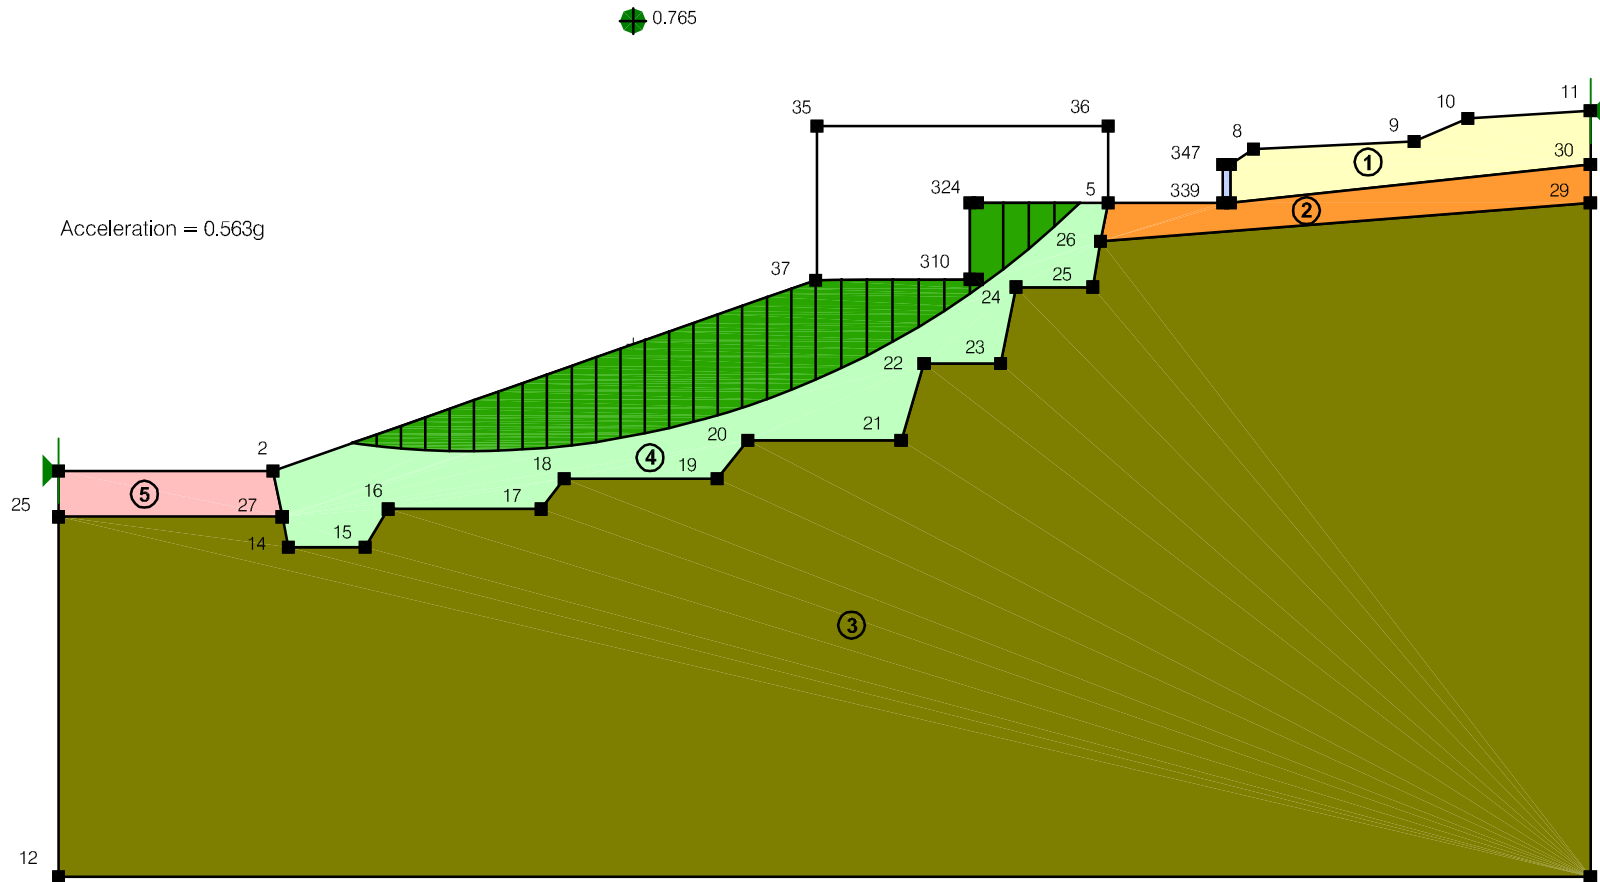
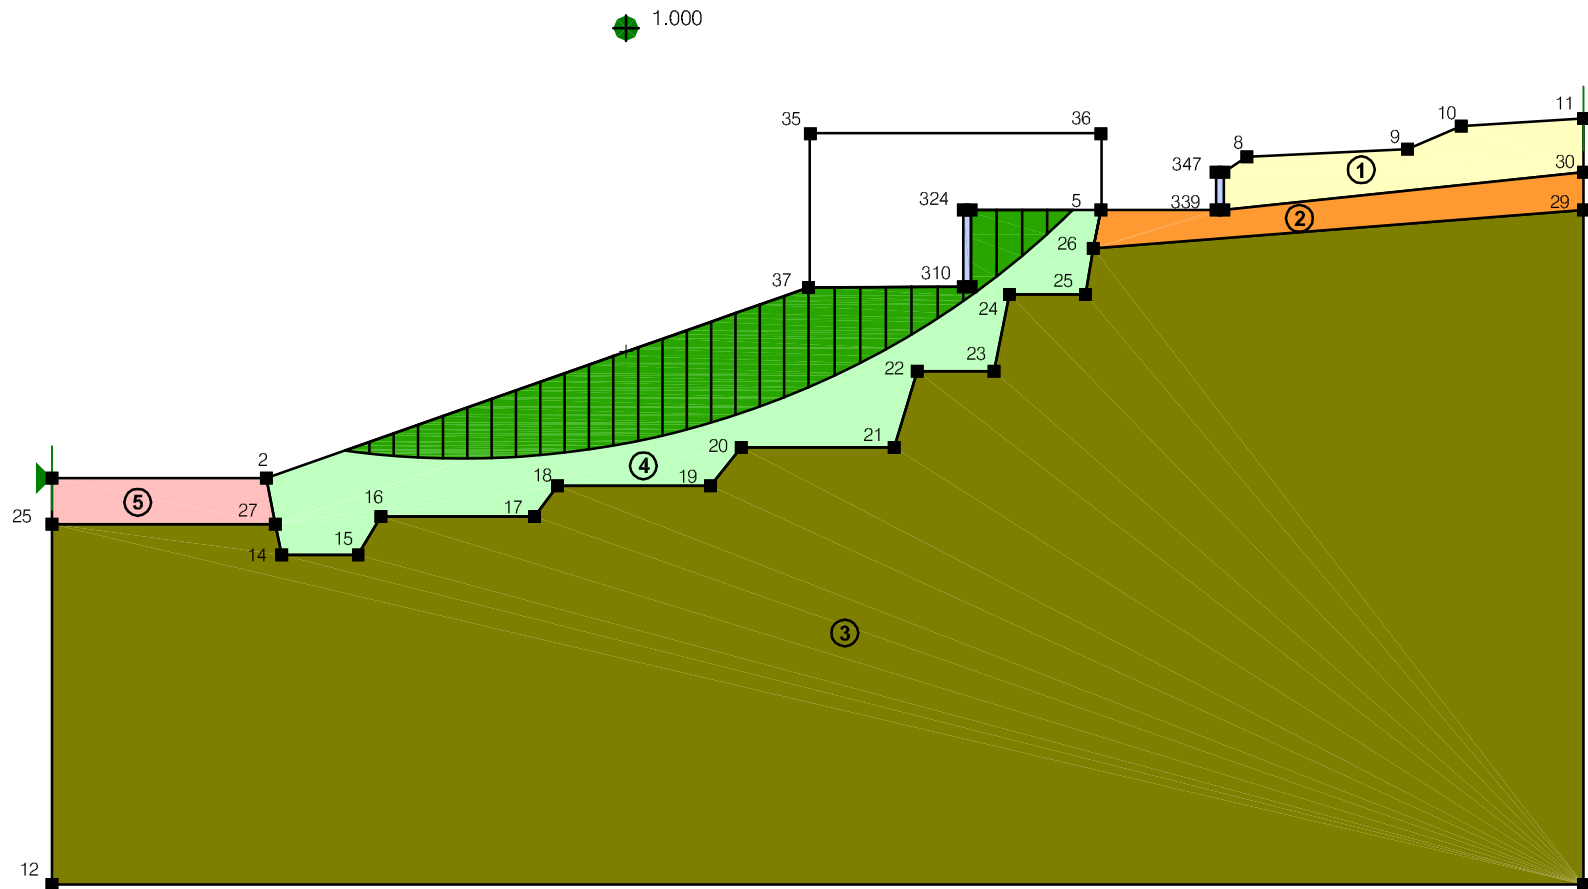
The static analysis minimum factor of safety for the overall repaired slope was approximately 2.37, which was greater than the generally accepted minimum static factor of safety of 1.5.

For the pseudo-static analysis, an earthquake was represented as an equivalent horizontal static force, which was determined by multiplying the mass of potential slide material by a horizontal ground acceleration. For a magnitude 7.9 Earthquake along the San Andreas Fault, a peak seismic coefficient of 0.844g was determined in accordance with the 2006 International Building Code, which corresponded to a repeatable acceleration of 0.563g used in the analysis. With the above acceleration, the minimum factor of safety was determined to be less than 1.0 for the overall repaired slope. A seismic force of 0.378g was determined to correspond to a factor of safety of 1.0 (yield analysis).

To further evaluate earthquake shaking effects, the method developed by Bray and Travasaro (2007) was used to estimate the seismic deformation of the repaired slope. For the analysis, the minimum yield acceleration for the repaired slide mass was determined to be approximately 0.378g, the spectral acceleration was determined to be 1.175g for the site, and the slope's initial Fundamental Period (Ts) was calculated to be 0.10 seconds, with a degraded period equal to 0.15 seconds. This slope displacement analysis indicated permanent slope displacements on the order of 8 to 9 centimeters during the peak earthquake event.

Treadwell & Rollo concluded that the above deformation amount was relatively small and that slope failure hazards should be adequately mitigated for the lots by a buttress fill bearing in the underlying bedrock. They noted that the yield coefficient is dependent on the material strengths of the buttress fill materials and that lower strength materials than what was tested would likely cause greater slope deformations. We concur with Treadwell & Rollo's analysis.
