SITE NAME: MONTARA PEAK 2 T1 T5
SITE NUMBER: 8630, 8063, 8187, 8188, 41214
SITE ADDRESS: 3501 WHITING RIDGE ROAD
MONTARA, CA 94038

SPECIAL USE PERMIT RENEWAL

TITLE SHEET

Attachment 1- Plans

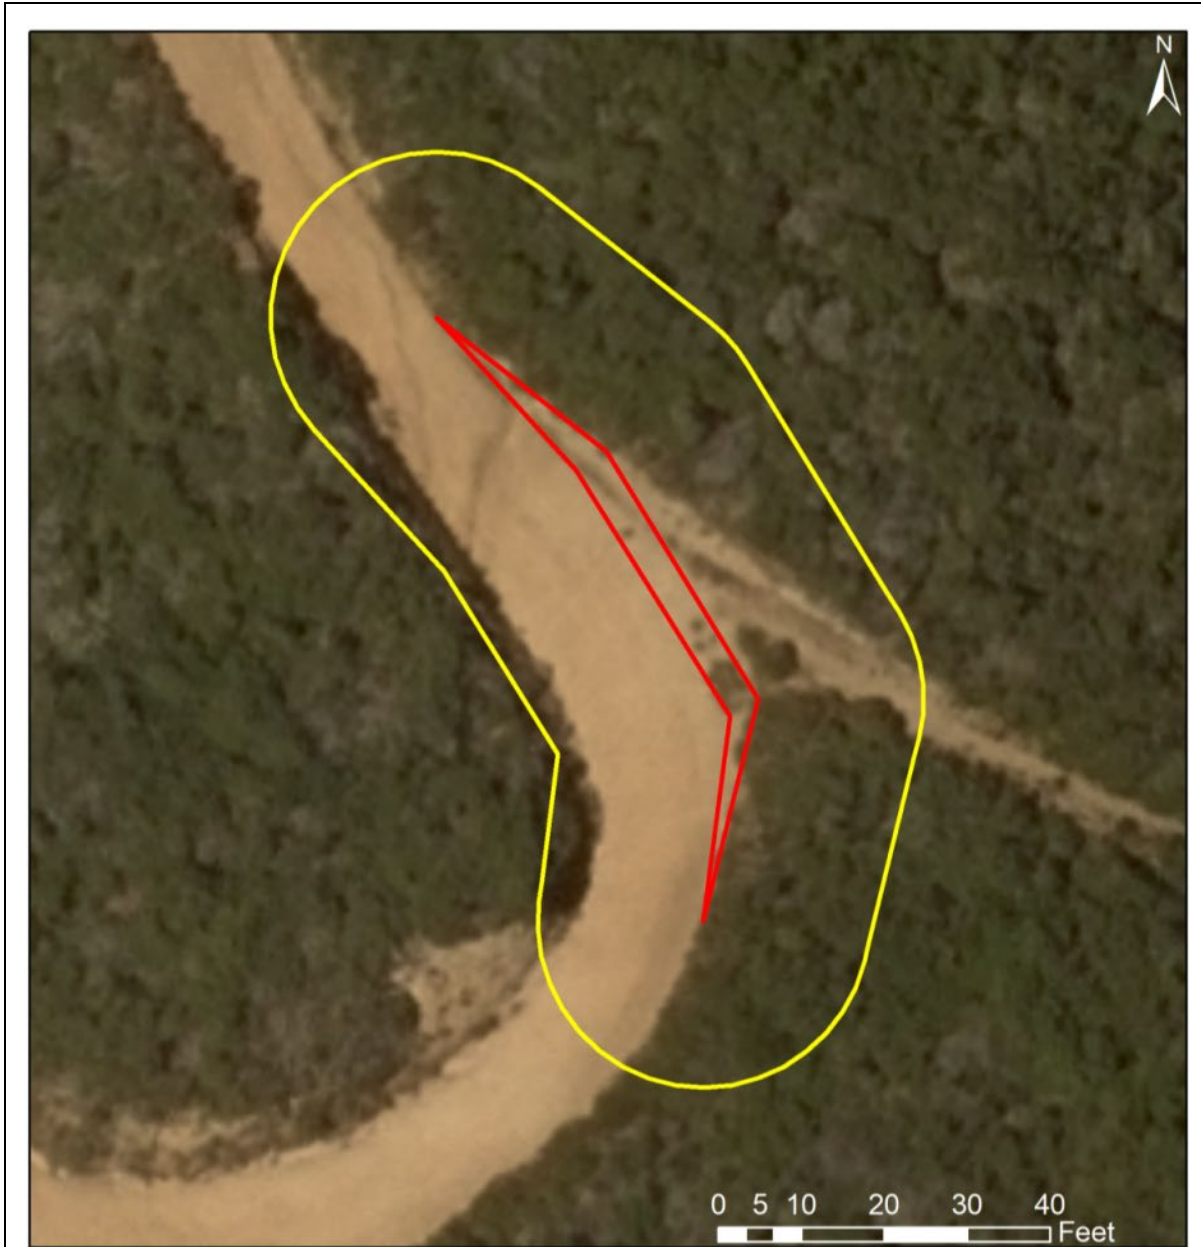
Figure 6: Turnout 1 Impact Detail Map

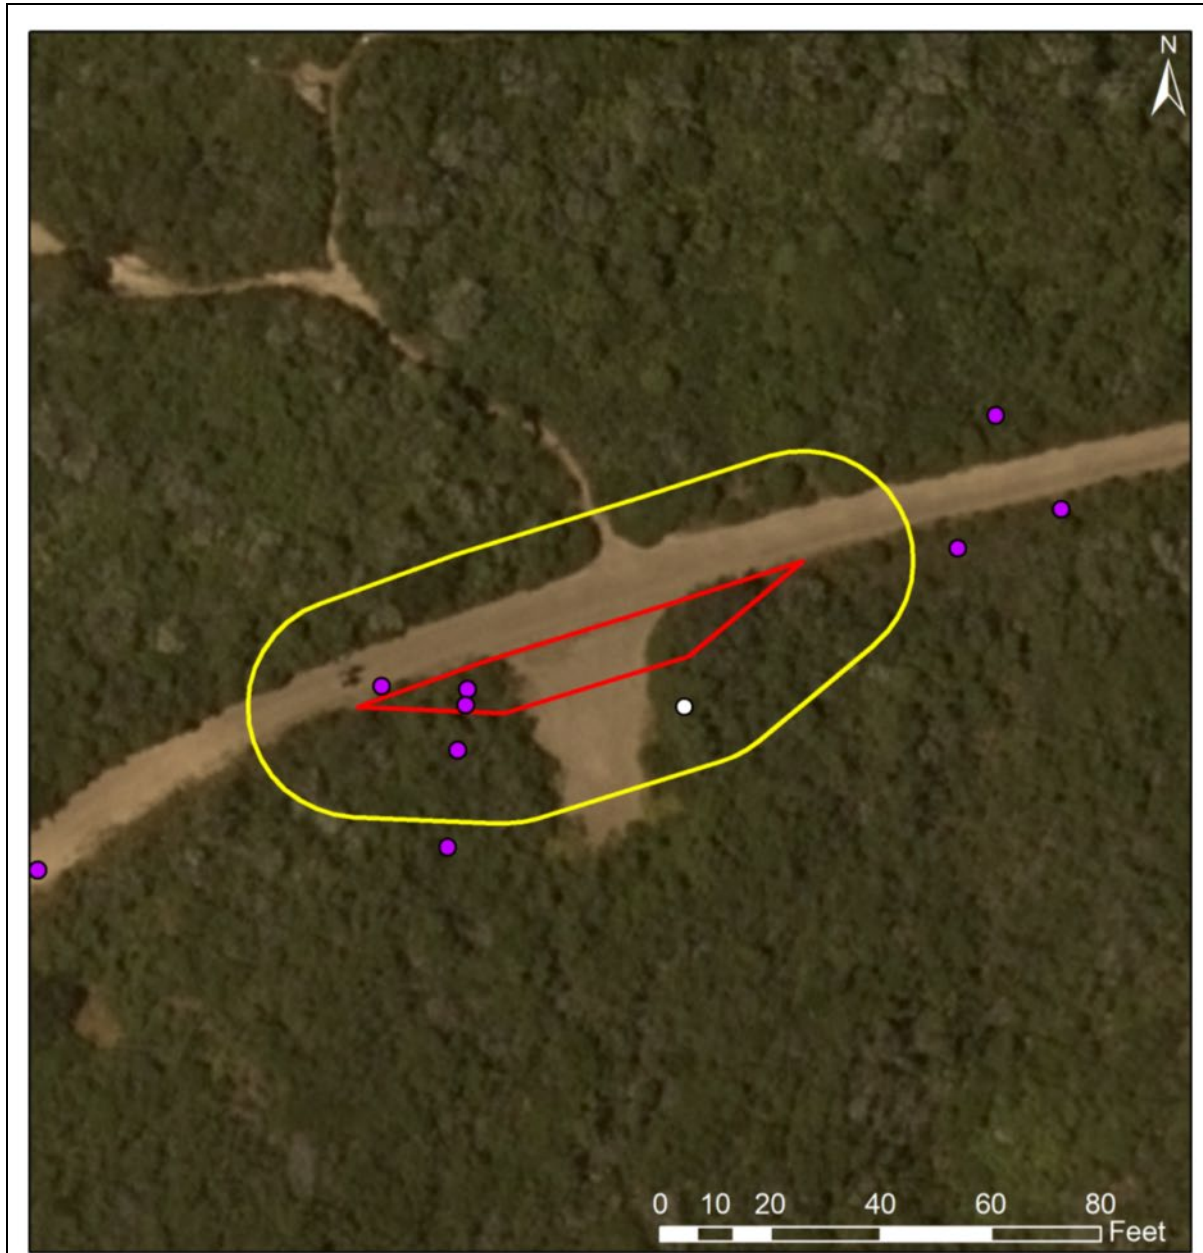
Figure 7: Turnout 2 Impact Detail Map

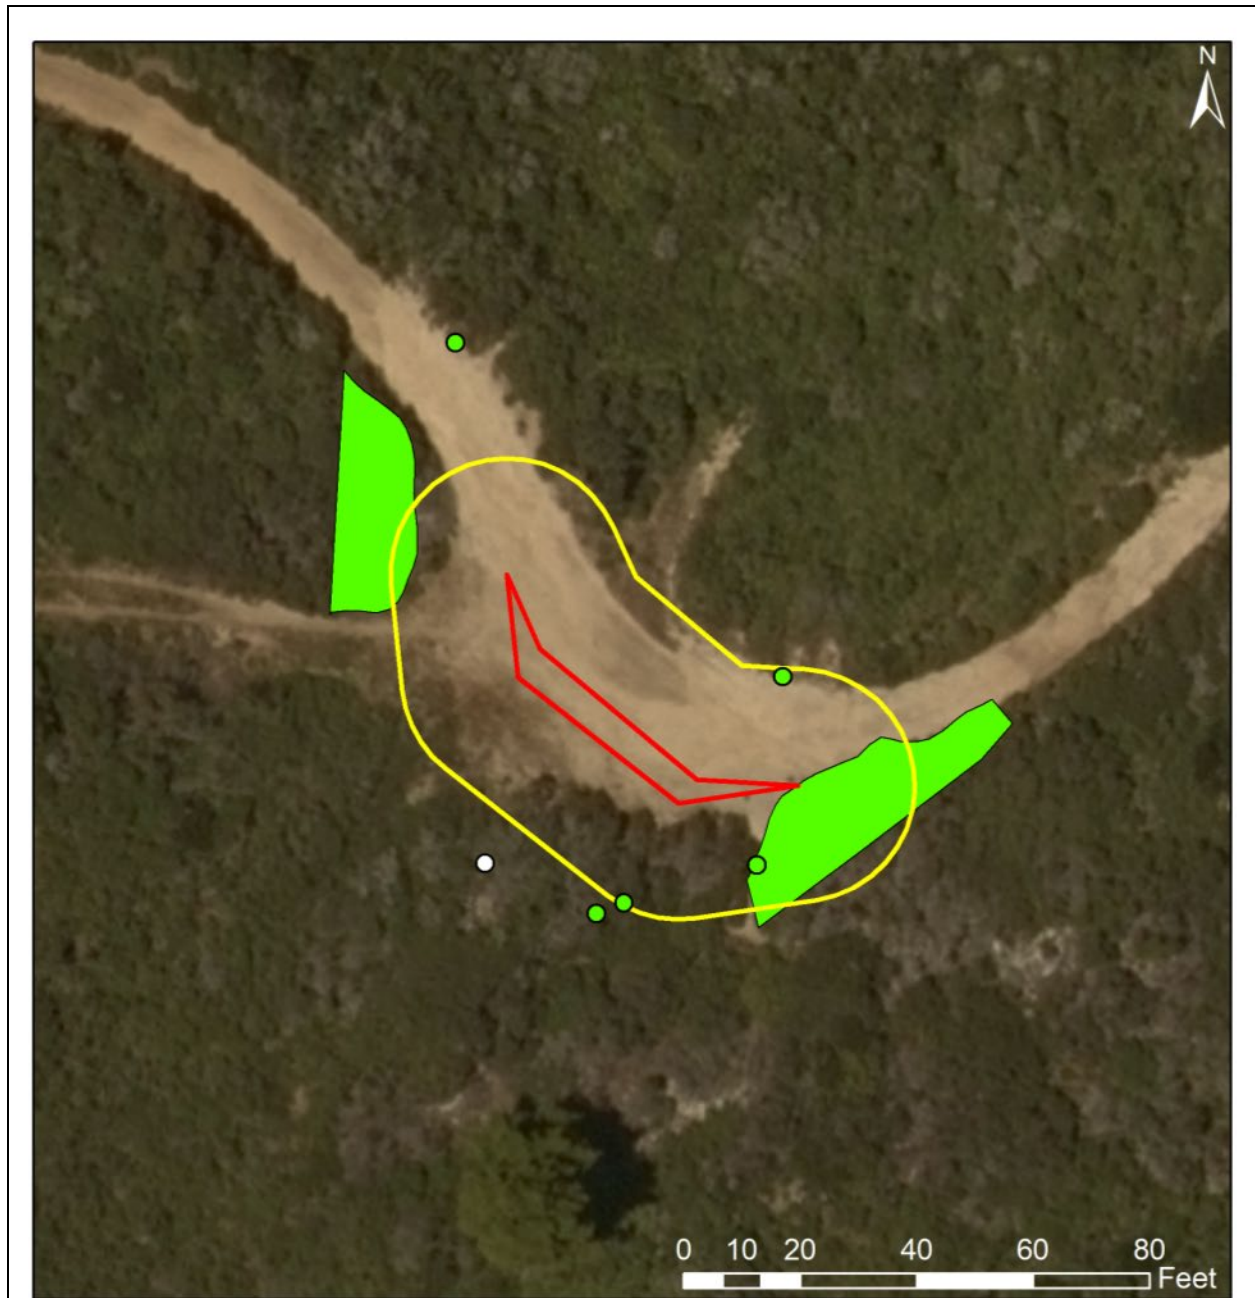
Figure 8: Turnout 3 Impact Detail Map

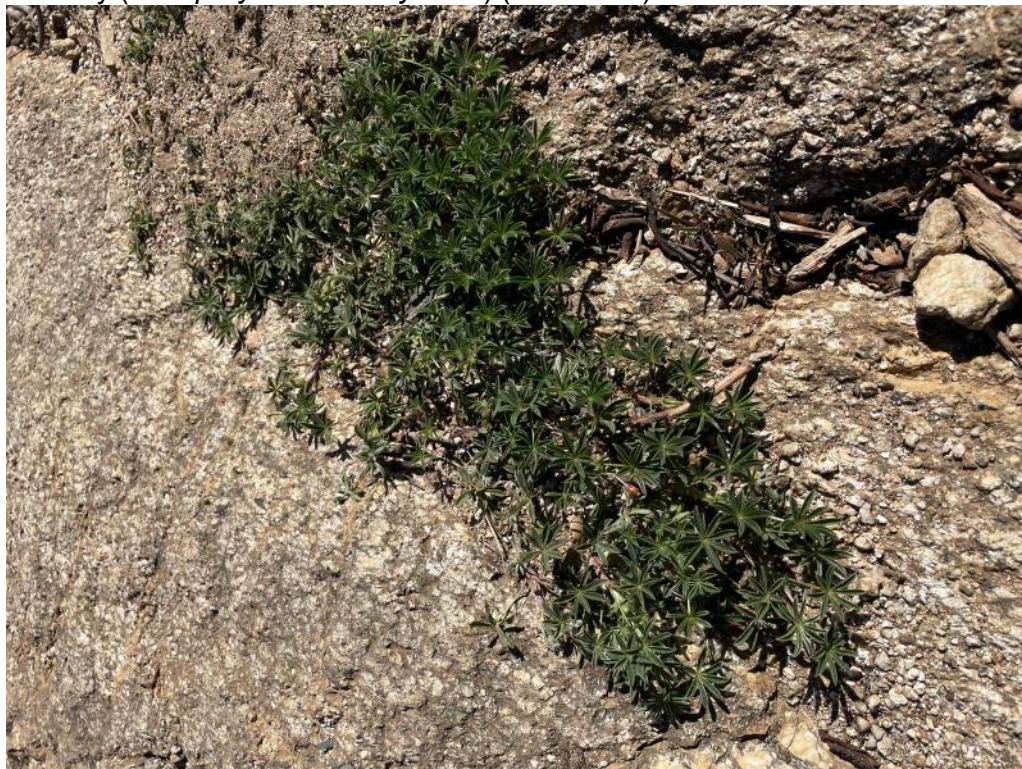
Photo B-8. Varied lupine (*Lupinus littoralis* var. *variicolor*) growing in middle of roadway where it is cut from bedrock. Potential host plant for the endangered Mission blue butterfly (*Icaricia icarioides missionensis*). (2/8/2022).

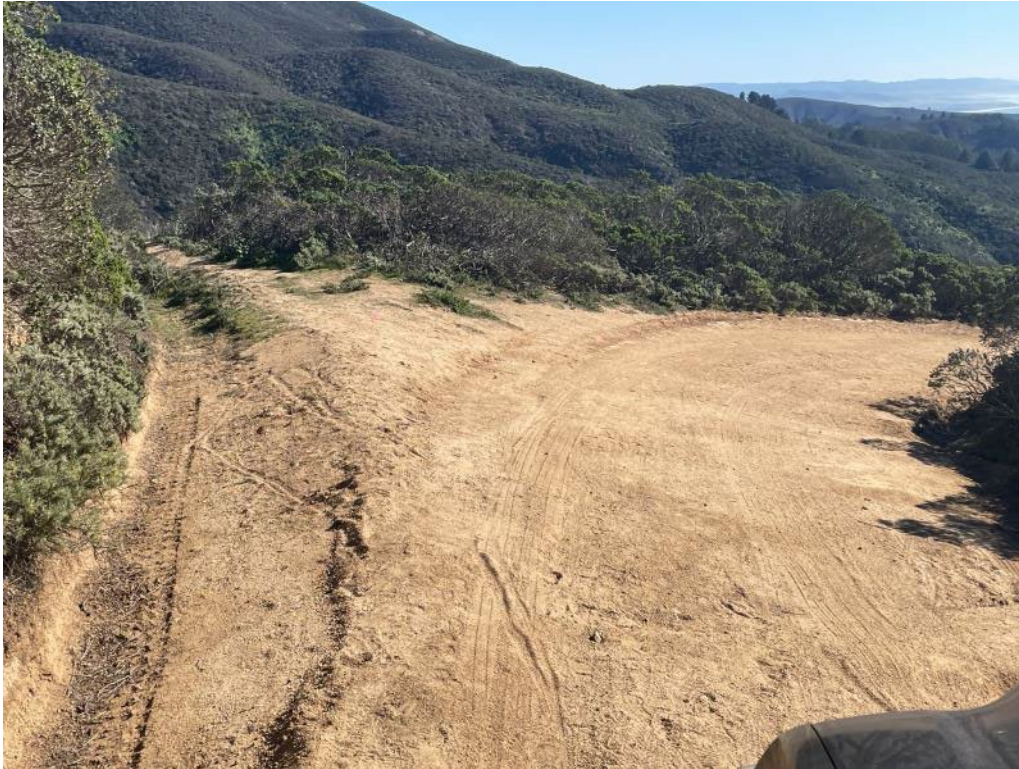
Photo B-11. Proposed location for Turnout 1 (2/8/2022)

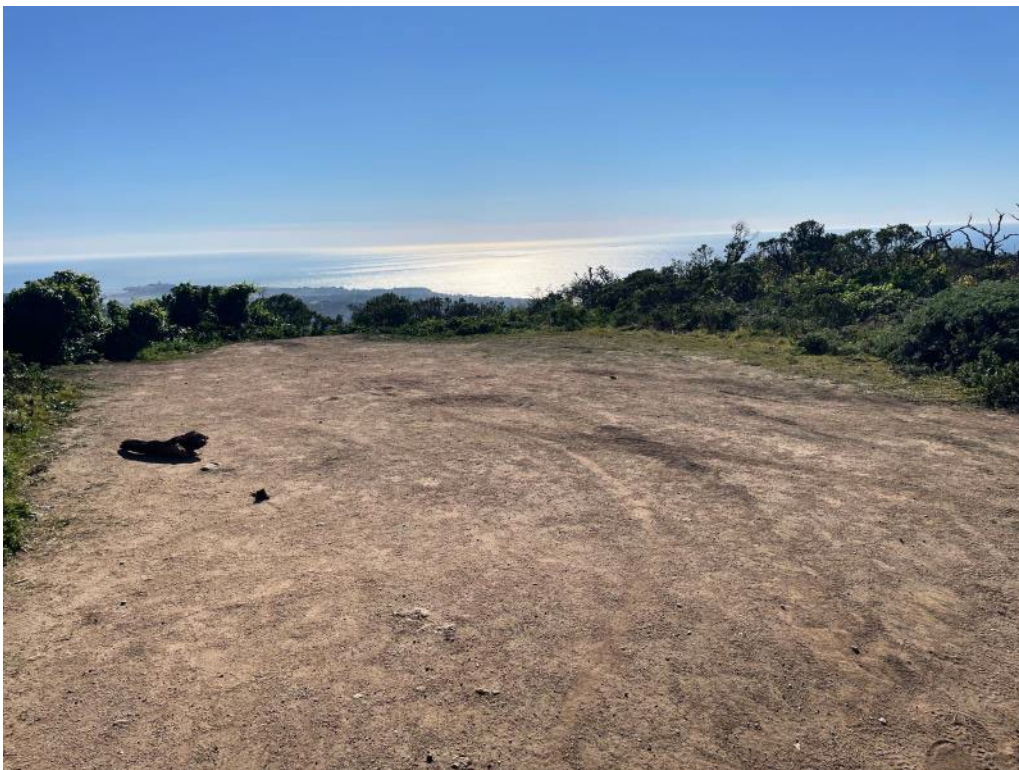
Photo B-12. Proposed location of Turnout 2 (2/8/2022)

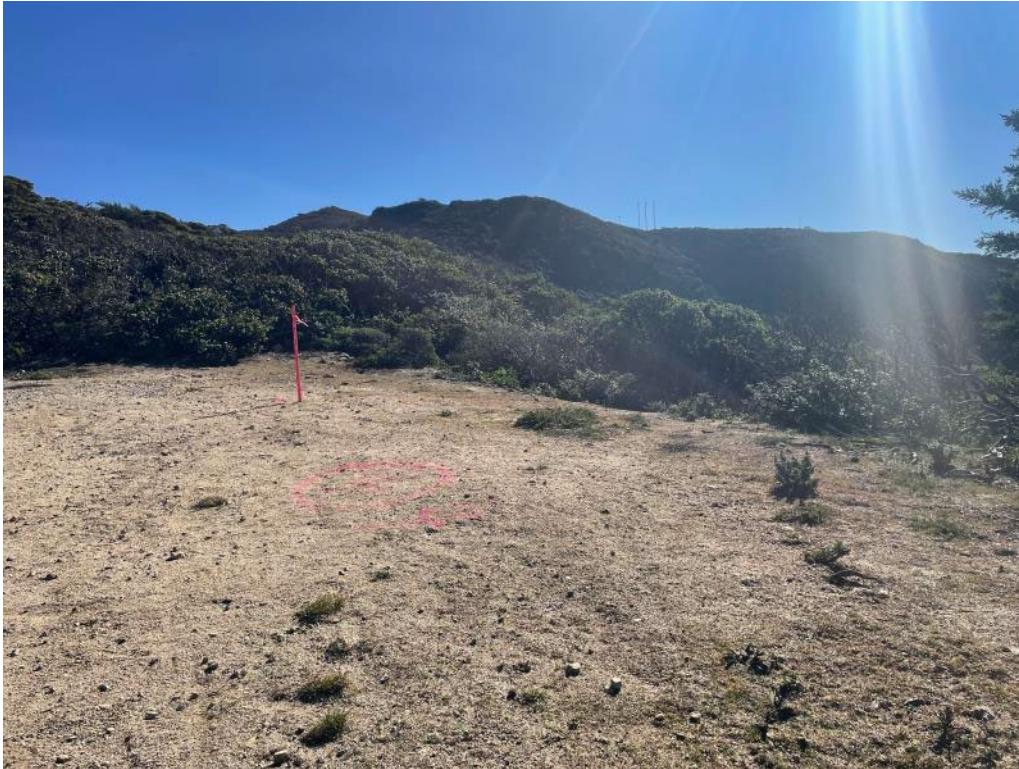
Photo B-13. Proposed location of Turnout 3. Montara manzanita visible on left side of photo (2/8/2022)

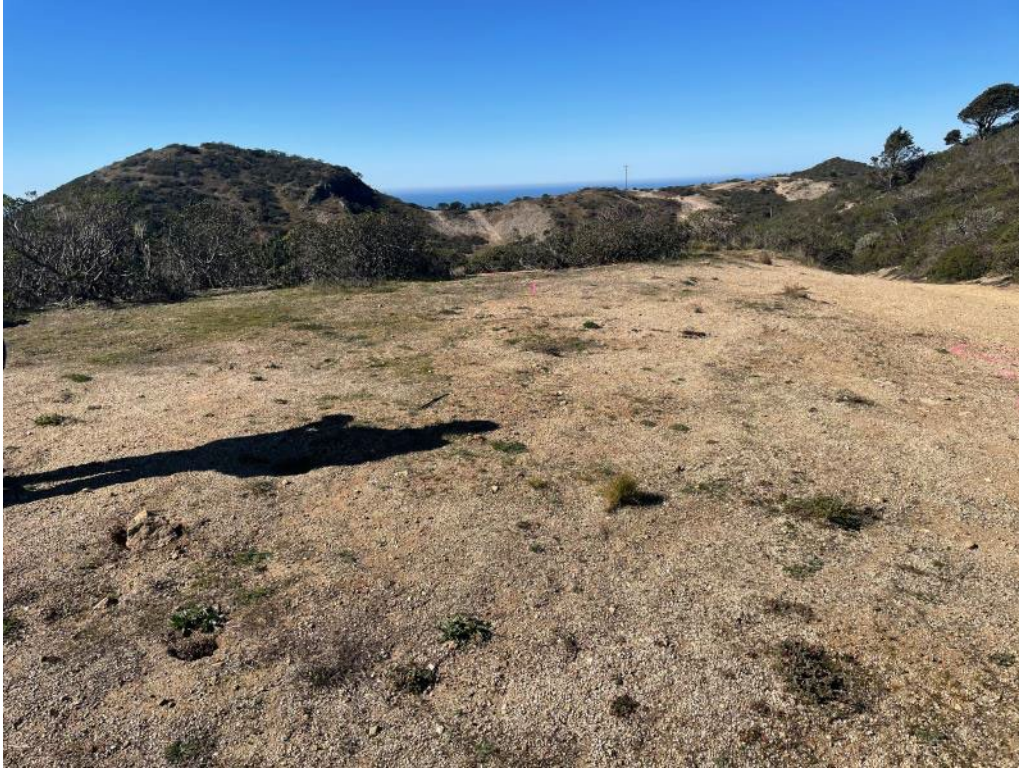
Photo B-15. Proposed location of Turnout 4 (2/8/2022)

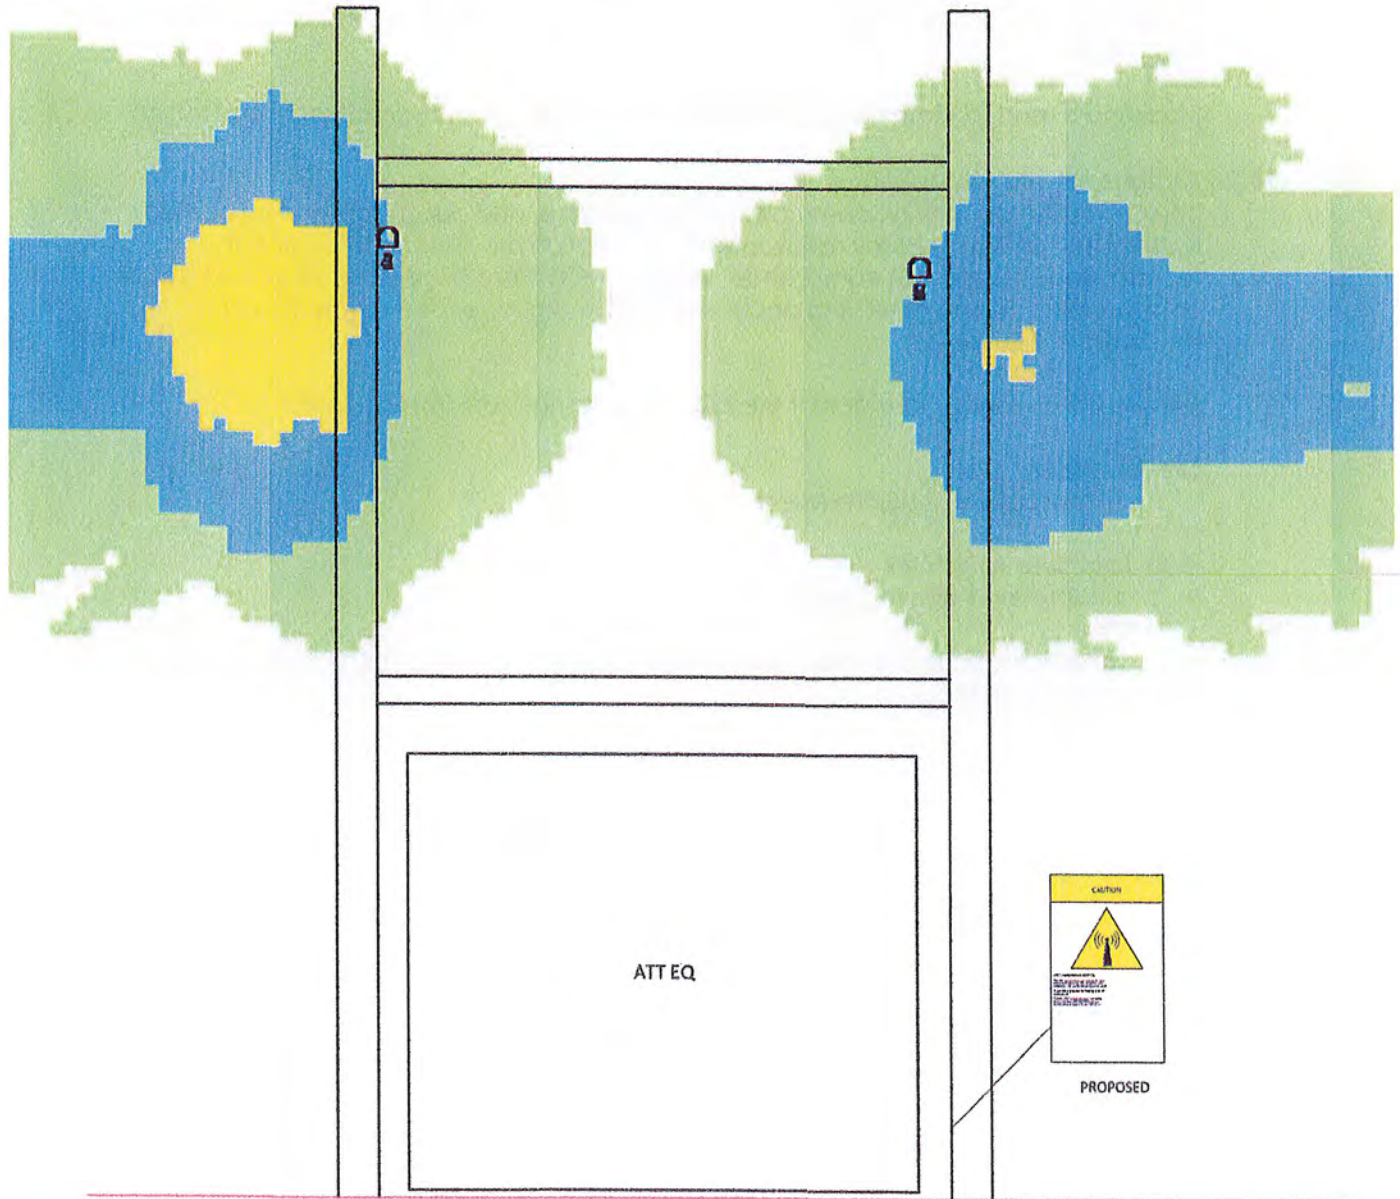
RF Exposure Simulation For: Montara Park CA
Elevation View

% of FCC Public Exposure Limit
Spatial average 0' - 6'
