Subject: Re: Lot 11, The Highlands

The current site design for lot 11 is:

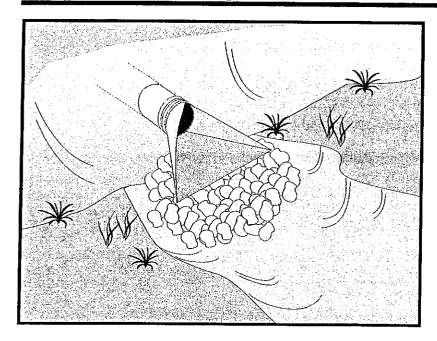
EC Erosion Control SE Sediment Control

TC Tracking Control

Outlet protection is a physical device composed of rock, grouted riprap, or concrete rubble, which is placed at the outlet of a pipe or channel to prevent scour of the soil caused by concentrated, high velocity flows.
