PROPOSED RESIDENCE  
EL NIDO ROAD  
PORTOLA VALLEY, CALIFORNIA

ENGINEERING GEOLOGIC RECONNAISSANCE  
AND GEOTECHNICAL INVESTIGATION

SEPTEMBER 2018

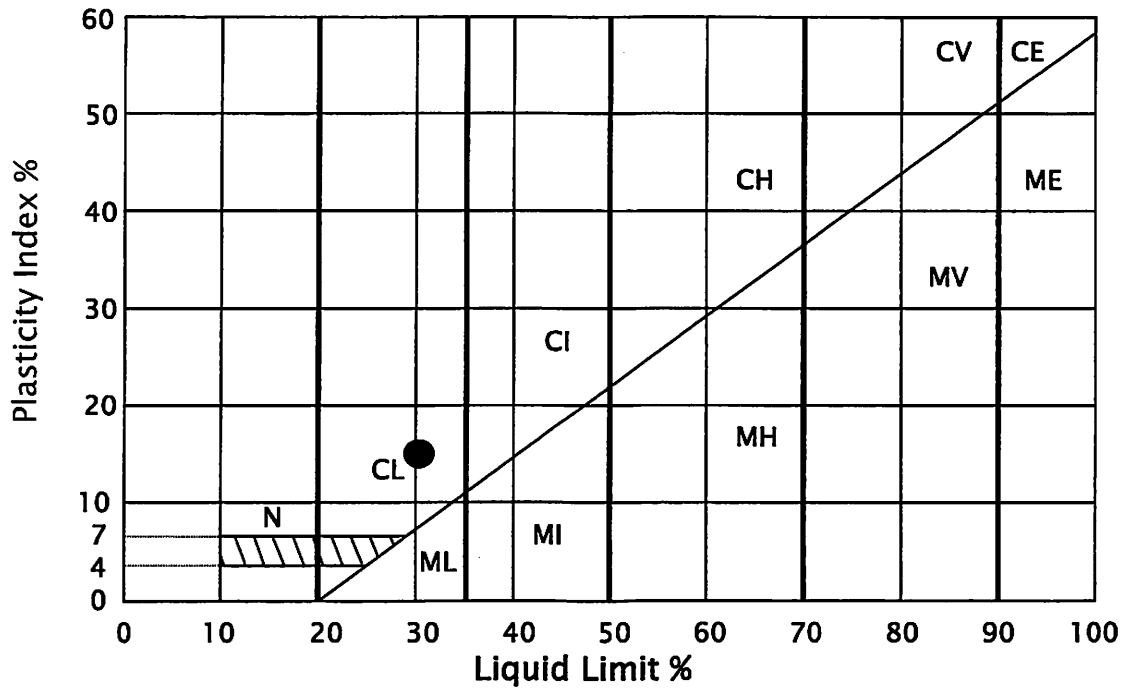
Silicon Valley Soil Engineering  2391 Zanker Road, #350 San Jose, CA 95131 (408) 324-1400	<b>PLASTICITY INDEX</b>  Proposed Residence  El Nido Road, Lot 140 Portola Valley, California	File No.: SV1784	FIGURE
		Drawn by: V.V.	4
		Scale: NOT TO SCALE	September 2018

### PLASTICITY CHART

### PLASTICITY DATA

Key Symbol	Hole No.	Depth ft.	Liquid Limit %	Plasticity Index %	Unified Soil Classification Symbol *
●	BAG A	0-1	30	15	CL
