County of San Mateo Planning & Building Department Agricultural Advisory Committee

SUBJECT: Consideration of Local Coastal Program amendment to facilitate future construction of a replacement fire station (County Fire Station Number 59) and extension of CSA-11 to serve the fire station and Pescadero Middle/High School located at 350-360 Butano Cut Off. Both projects are located in the Pescadero area of the unincorporated San Mateo County.

The County of San Mateo proposes to amend the San Mateo County Local Coastal Program (LCP) to facilitate construction of a replacement County Fire Station (Station No.59 in Pescadero), partial demolition and remodel of the existing fire station at 1200 Pescadero Creek Road for use during emergencies, and CSA-11 (County Service Area 11) water line extension to serve the replacement fire station and the existing Pescadero Middle/High School located at 350-360 Butano Cut Off. The project is limited in scope for these critical facilities to continue to serve the surrounding south coast area and are not otherwise growth inducing.

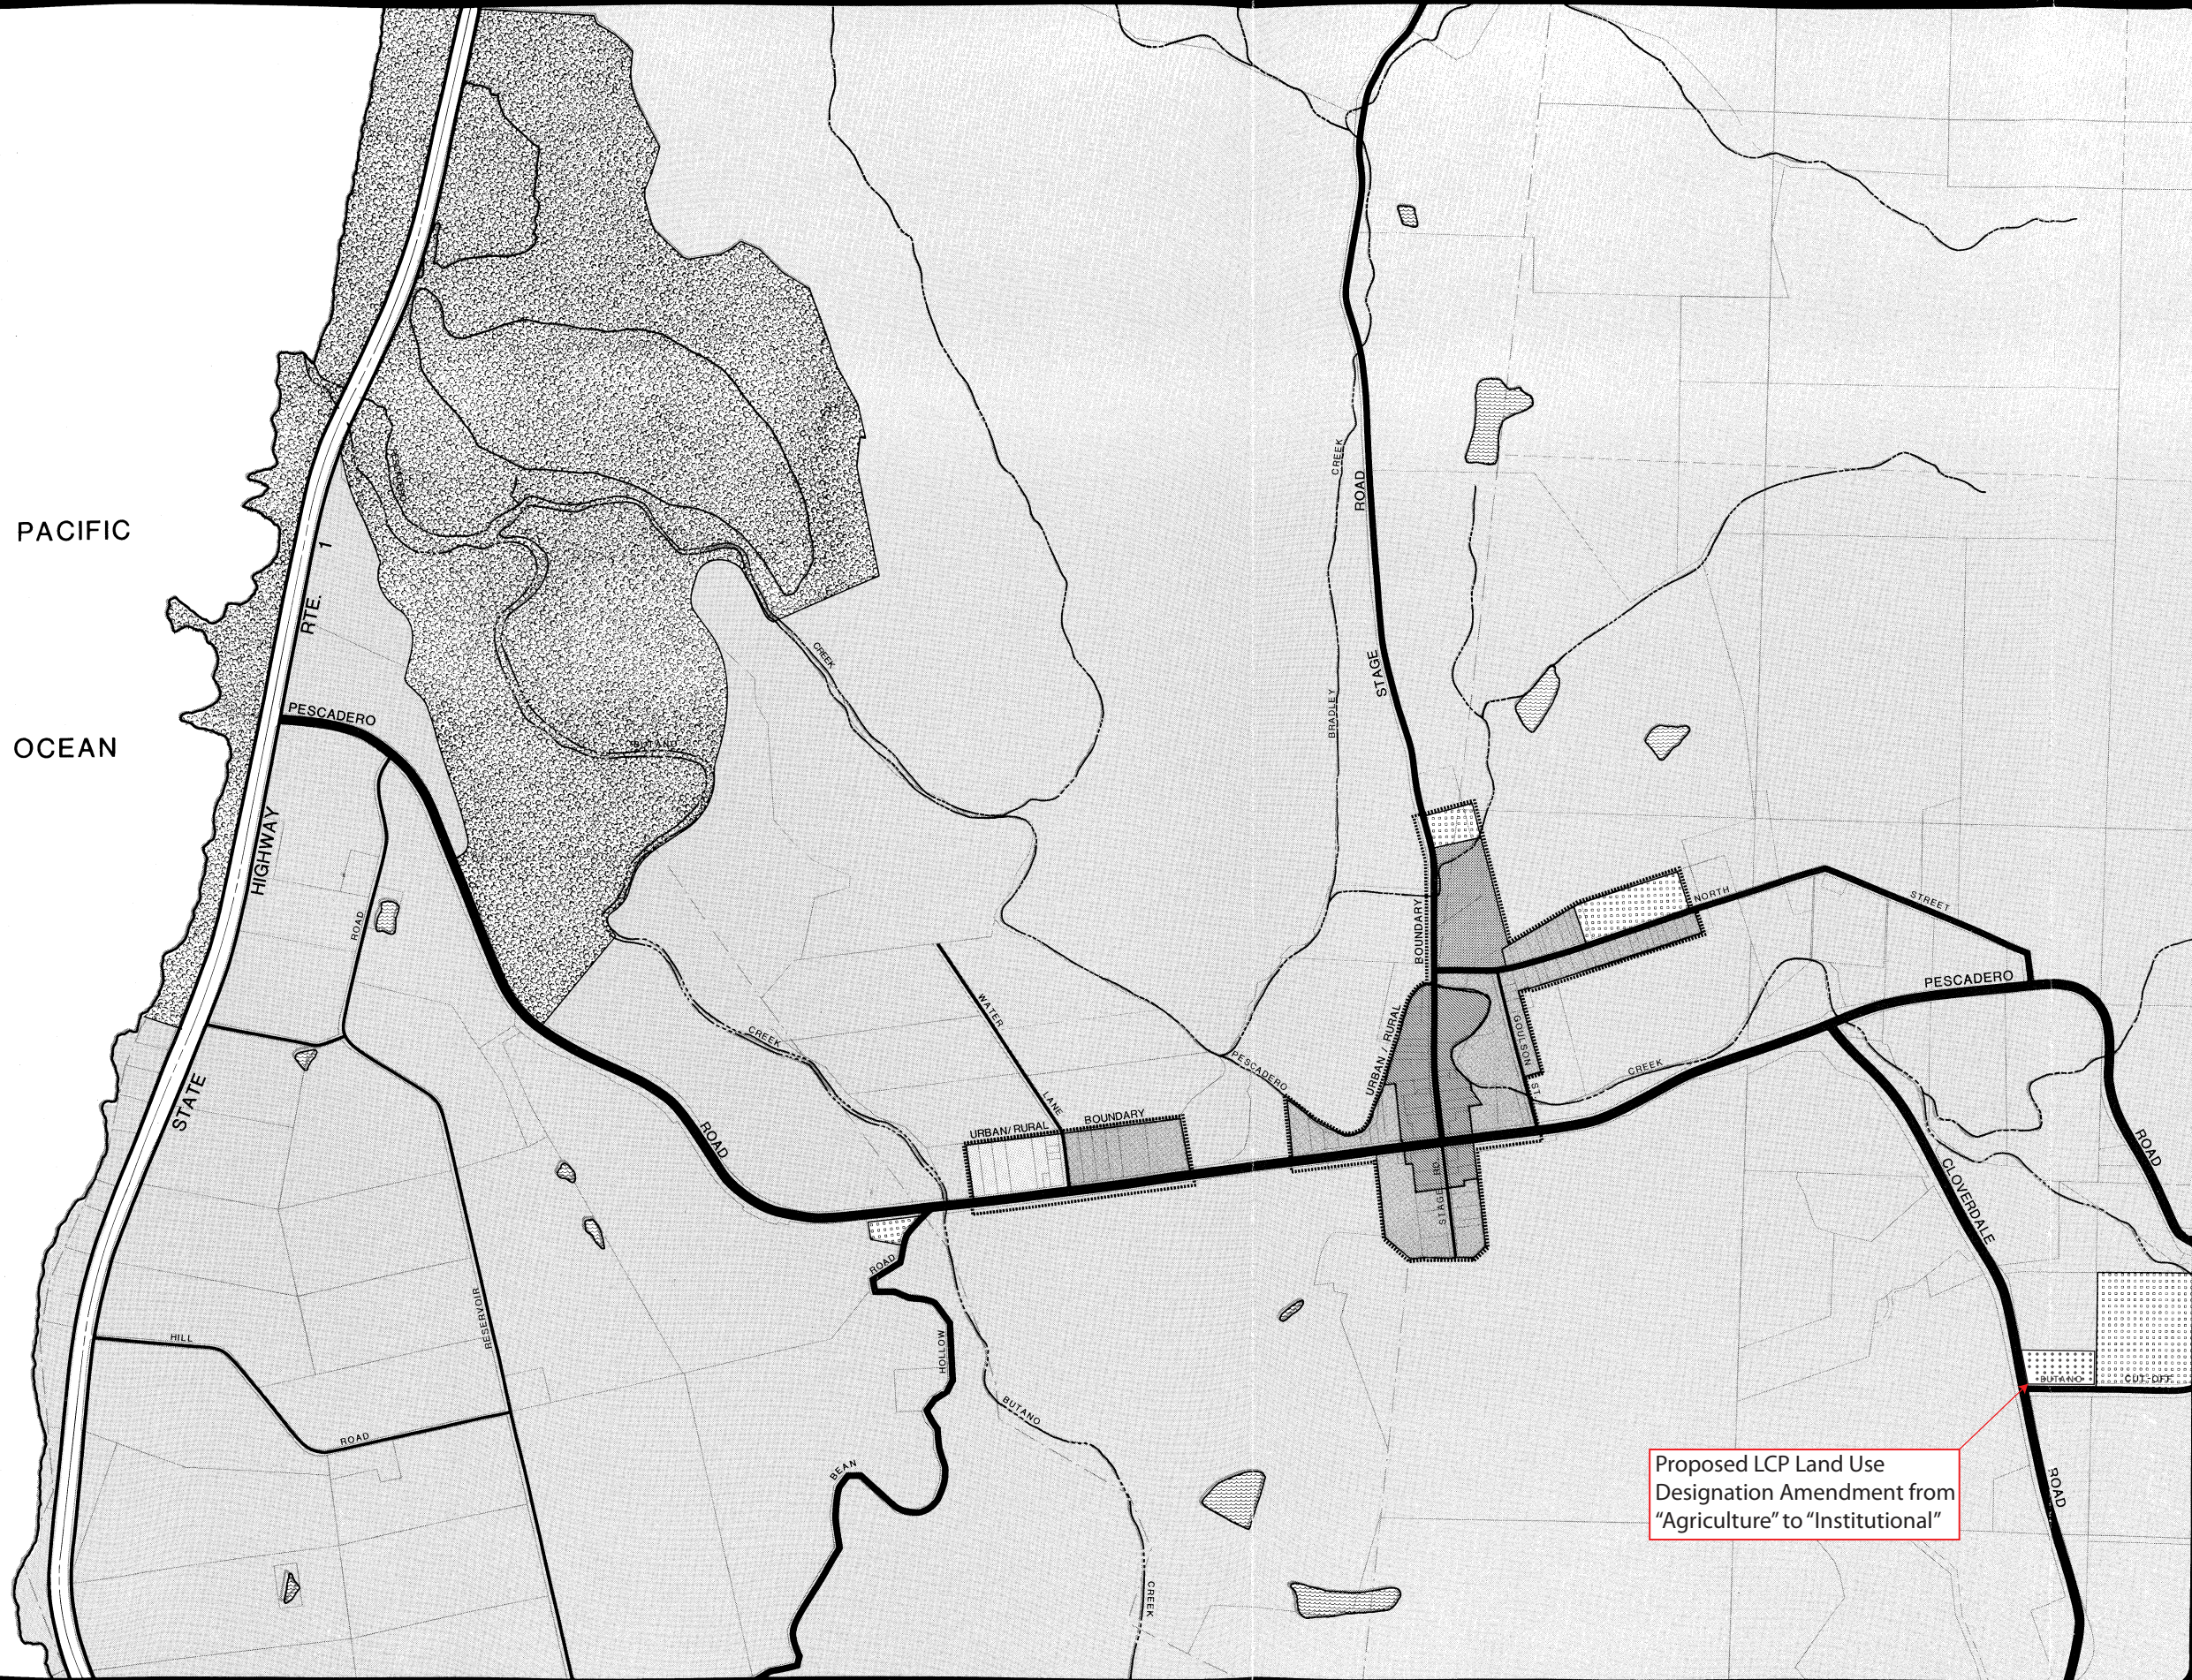
Proposed LCP Land Use Designation Amendment from "Agriculture" to "Institutional"

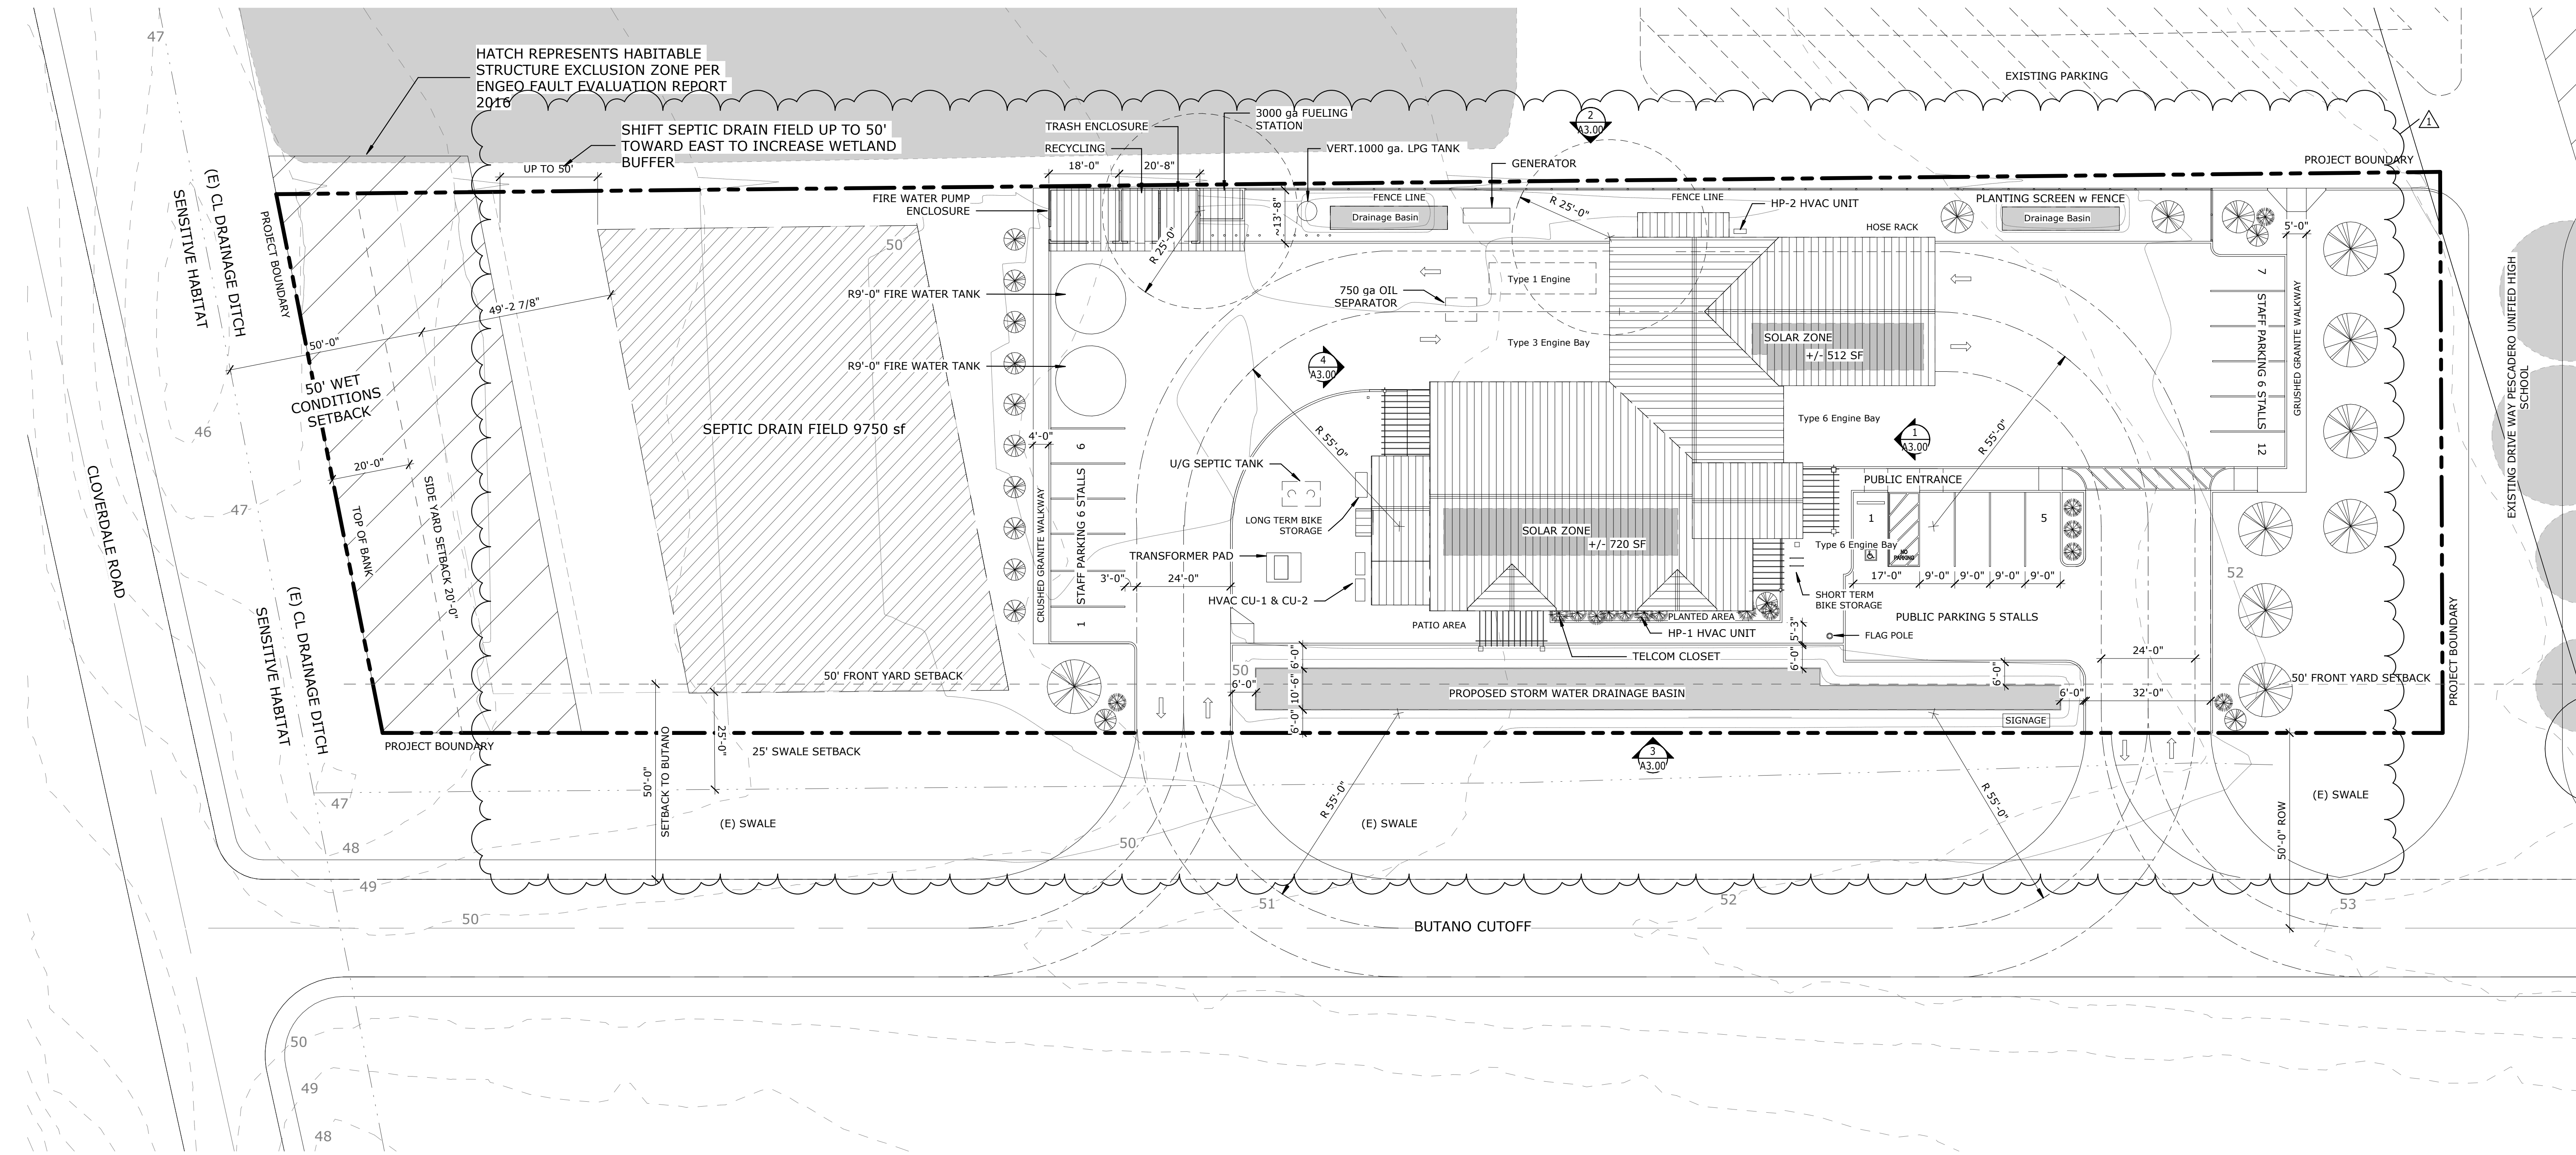
PROPOSED SITE PLAN
1" = 20'-0"

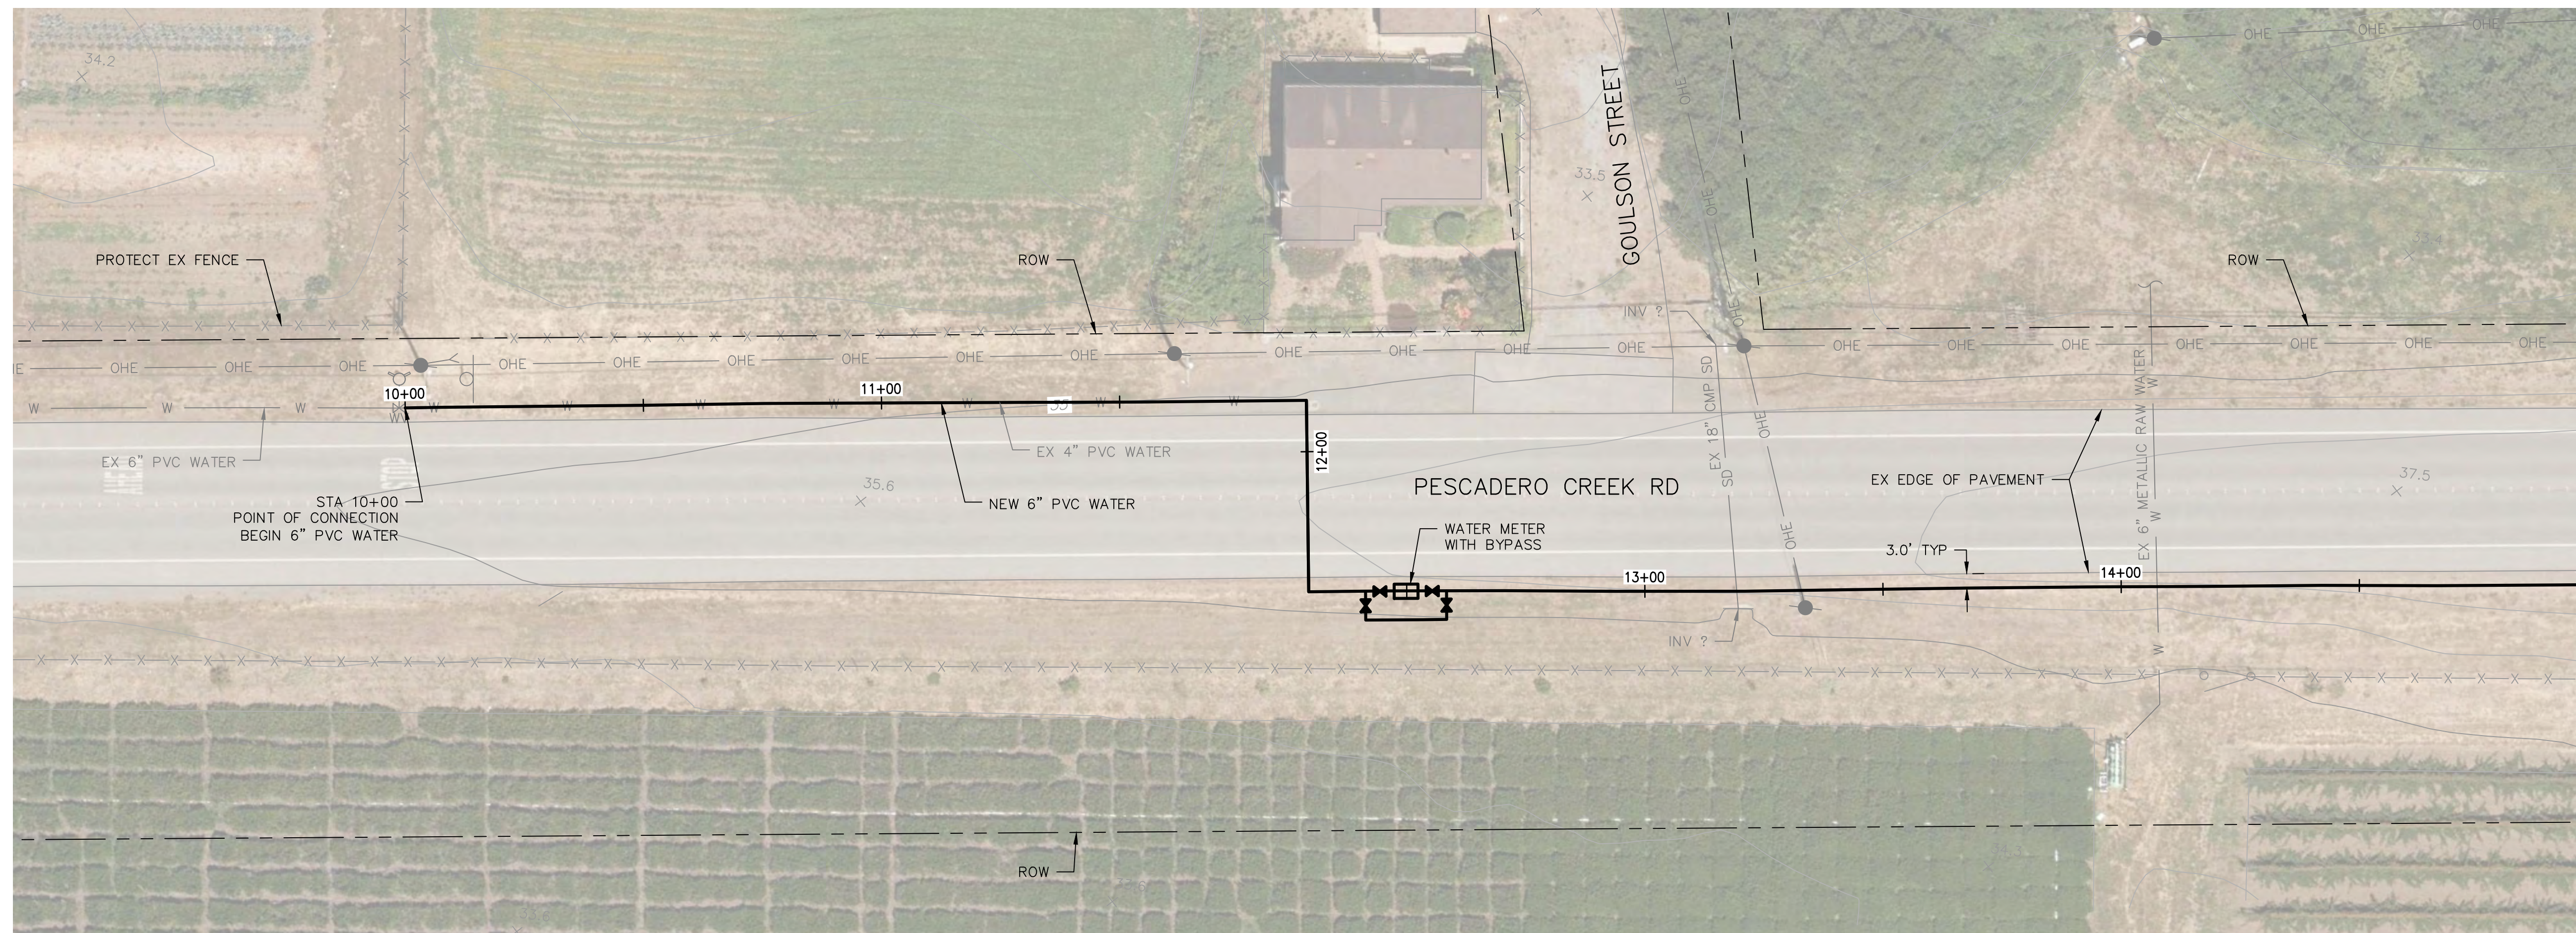
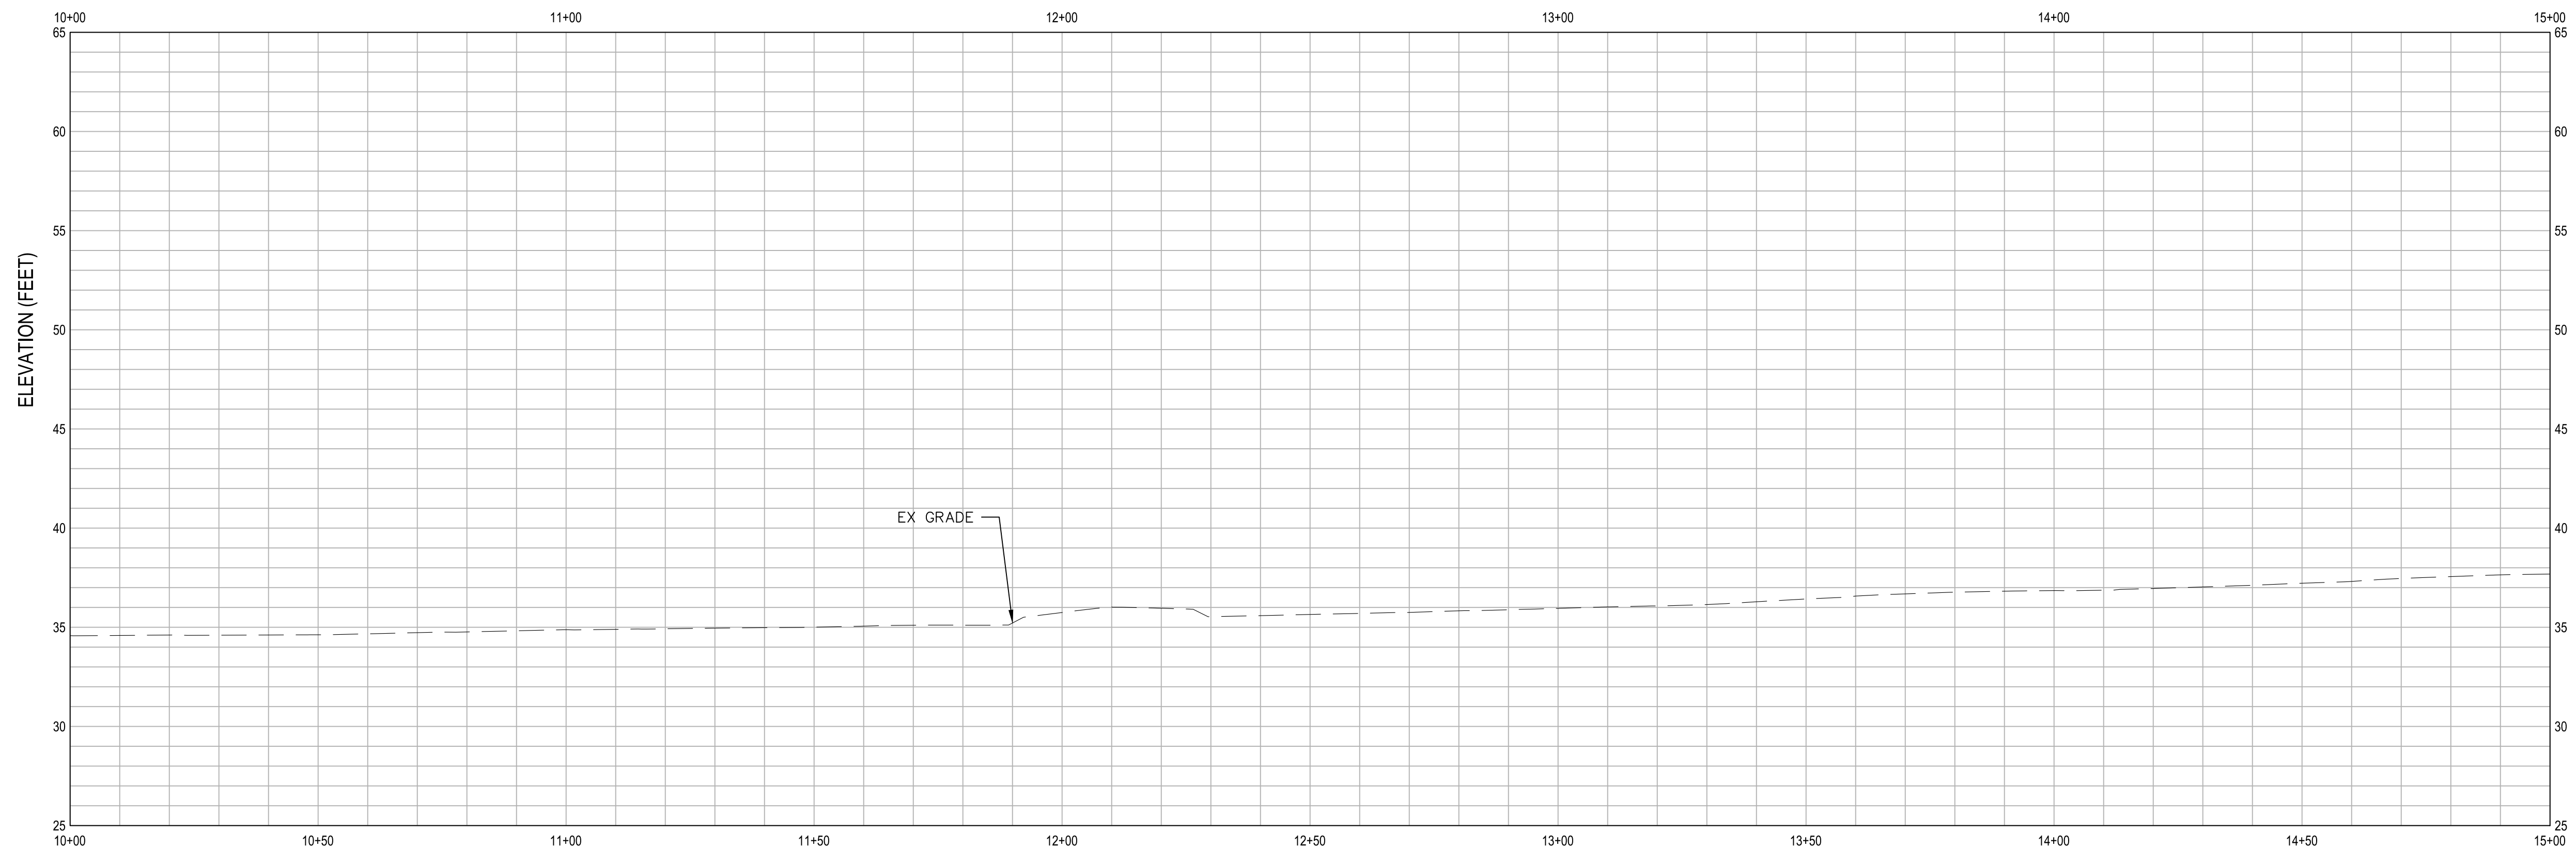
PLAN
SCALE 1"=20'

PROFILE
SCALE 1"=20' HZ, 1"=5' VT

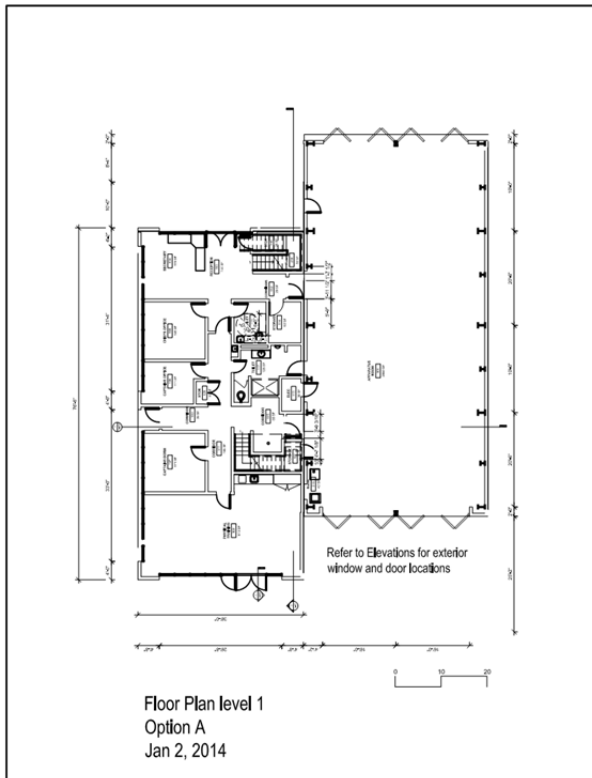
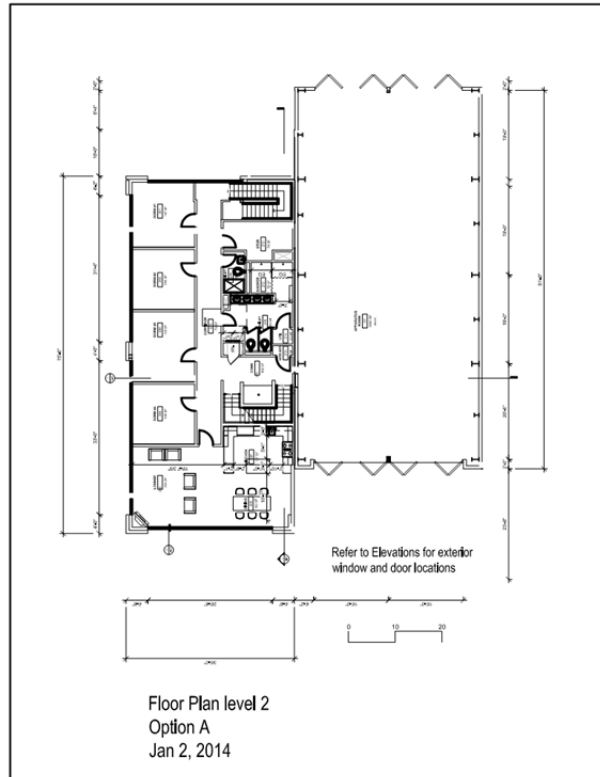
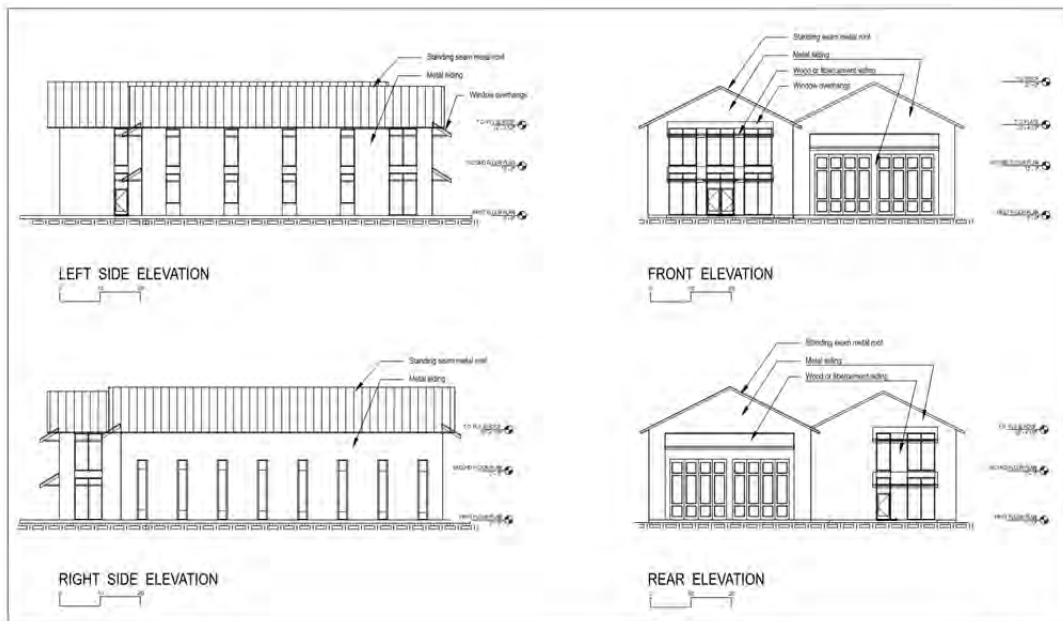
Option A
Jan 2, 2014

The structural system narrative is based on the concept architectural plans for a new apparatus building adjacent to an office and living quarters building as shown below. The two structures will be separate by a seismic joint.

The structural gravity system for the apparatus structure consists of steel beams in the transverse direction and along the perimeter supported on steel columns. Light gauge or wood roof framing members span between the steel beams to form the roof system. Exterior cladding is composed of either light gauge steel studs or wood studs spanning from the foundation to the roof framing level. The lateral system consists of steel moment frames in the transverse direction and plywood shear walls in the longitudinal direction. Reinforced masonry shear walls is an option to the plywood walls in the longitudinal direction. A plywood roof diaphragm is used to transfer seismic forces to the lateral system.

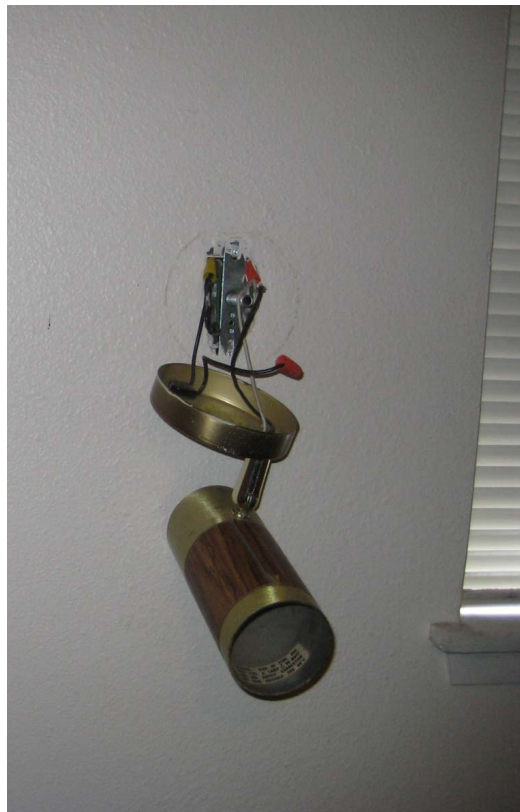
EE6 – Damaged light, Living Quarters

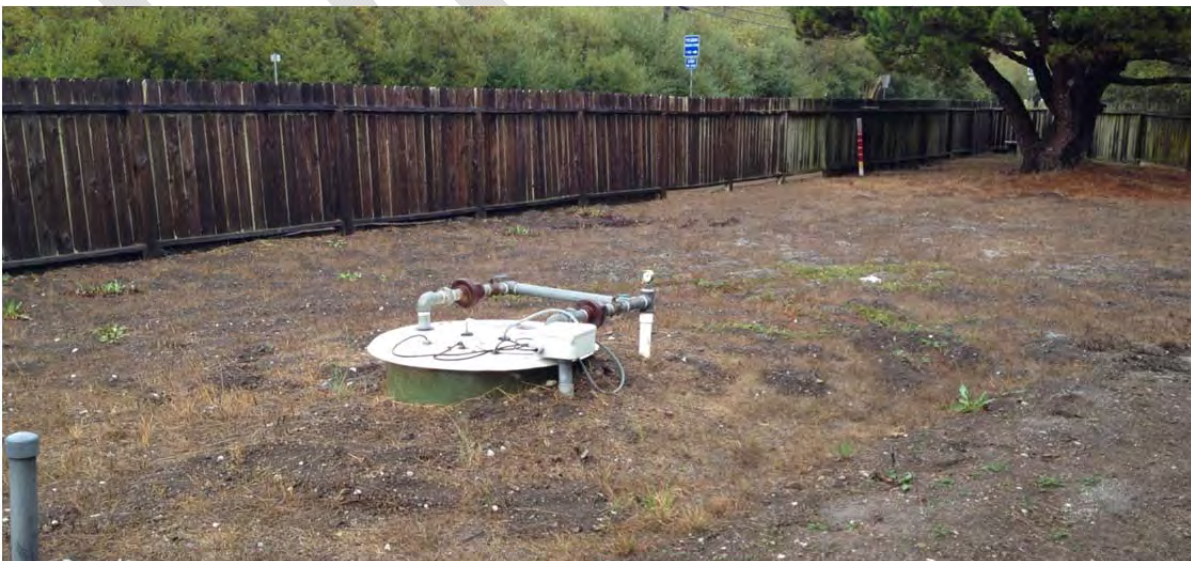
Septic field with flood elevation marker (white post with red marks) shown in the background

A new septic system will likely be required. The location of the existing system would be the ideal location if it has adequate space and soil conditions to accommodate a system that meets current code. Due to the likelihood of high groundwater at the location of the existing system, a shallow pressure dosing system would likely be required. However, because this location becomes inundated with water during flood events (see Photo 1), it is unlikely that this location will meet code. As such, alternative locations on site should be considered such as the western side of the site or on the hillside along the southern end of the site. It is unlikely, however, that the southern end will be feasible due to the steep slope and the confined area.

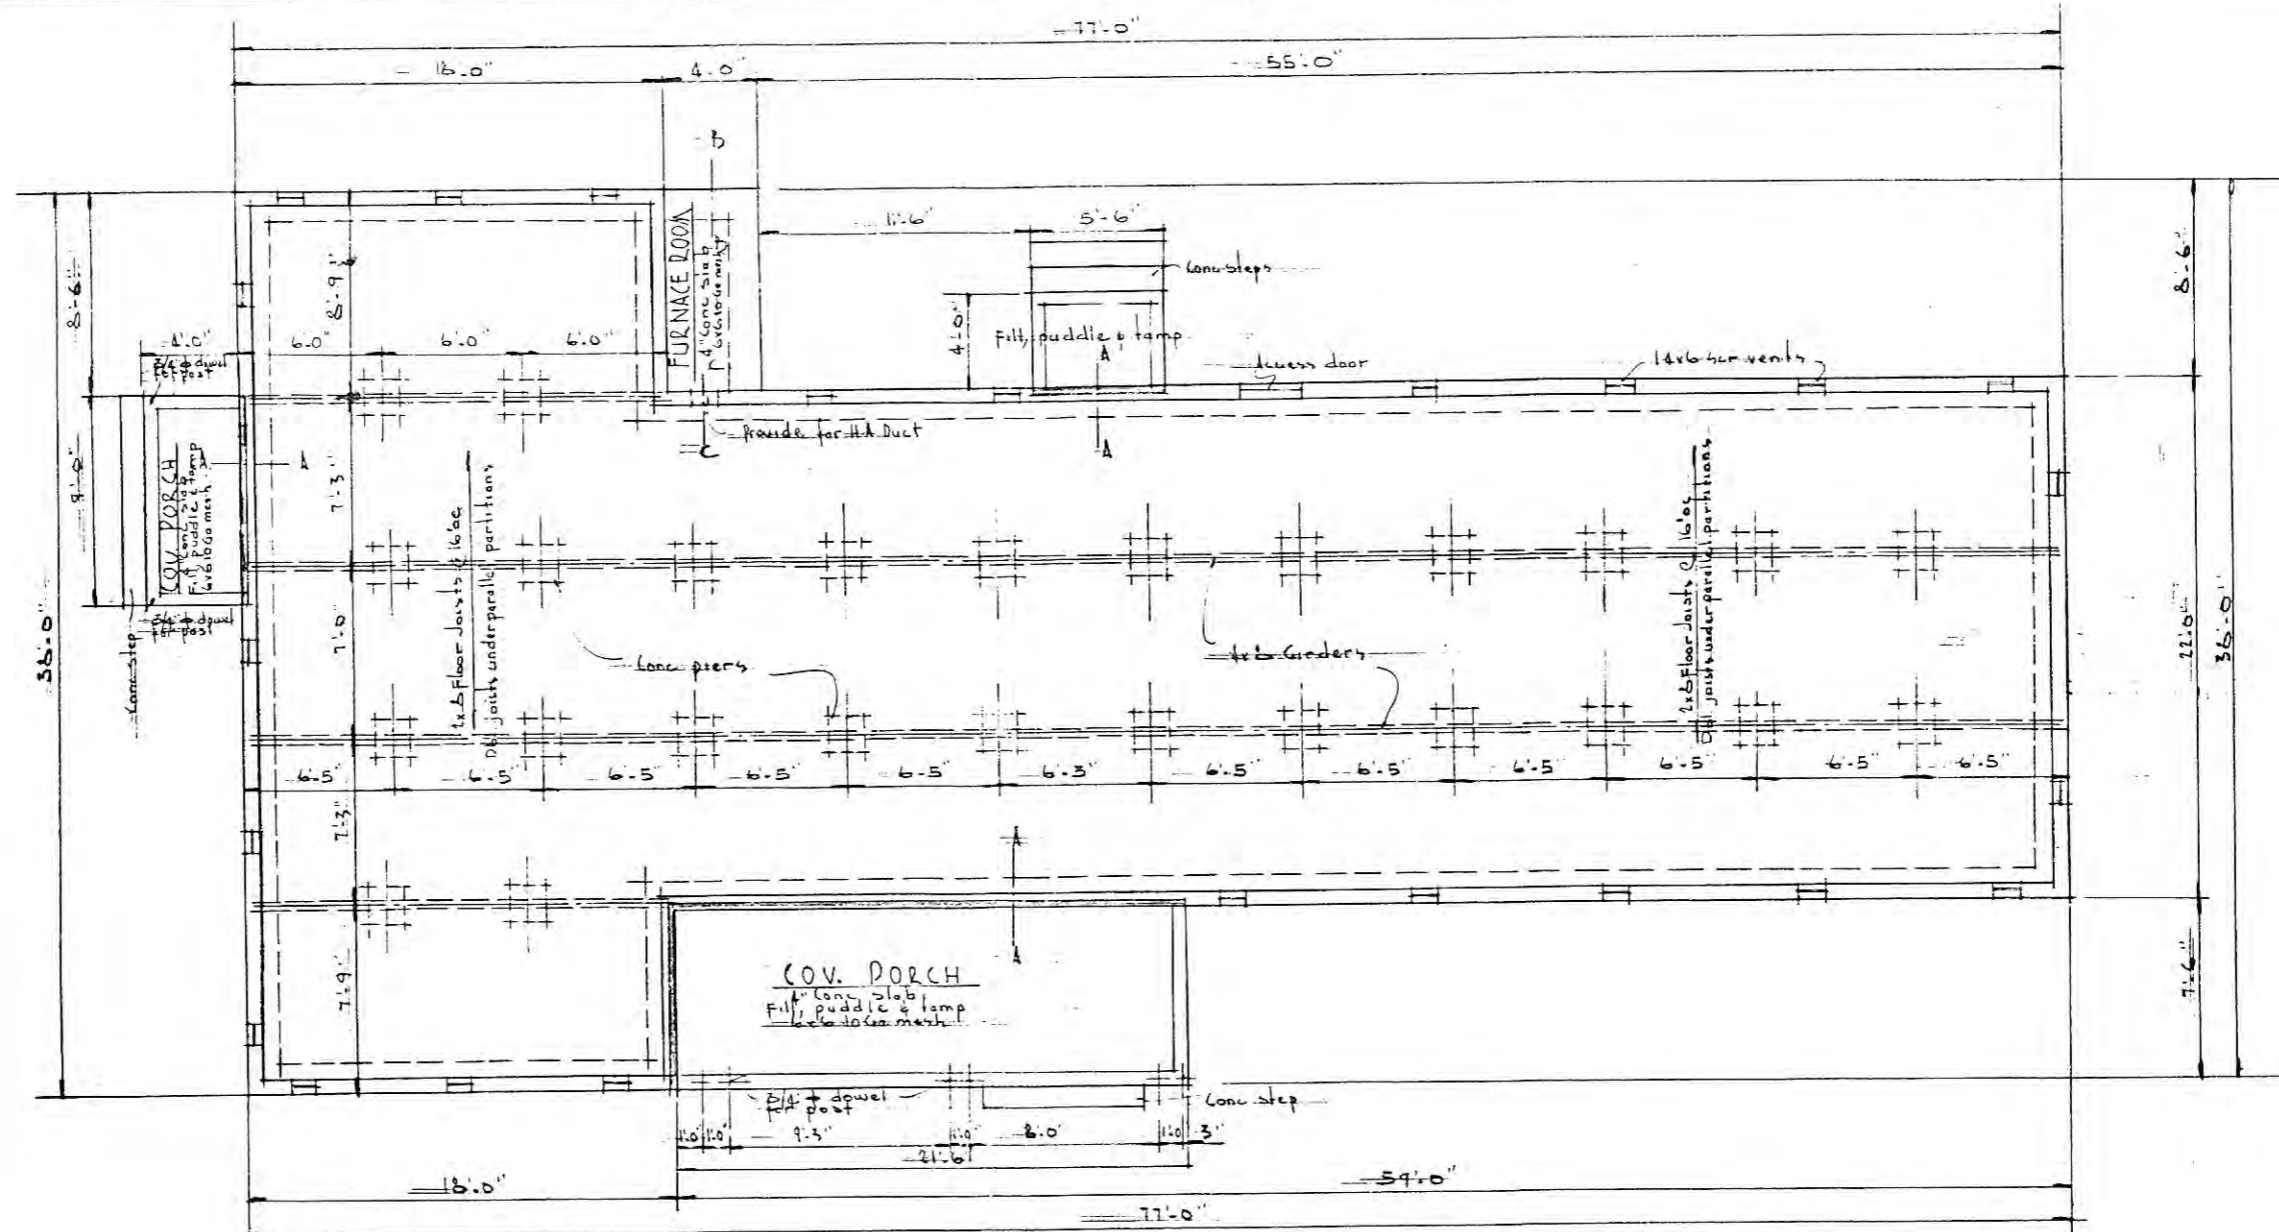
FOUNDATION PLAN
Scale: 1/4" = 1'-0"

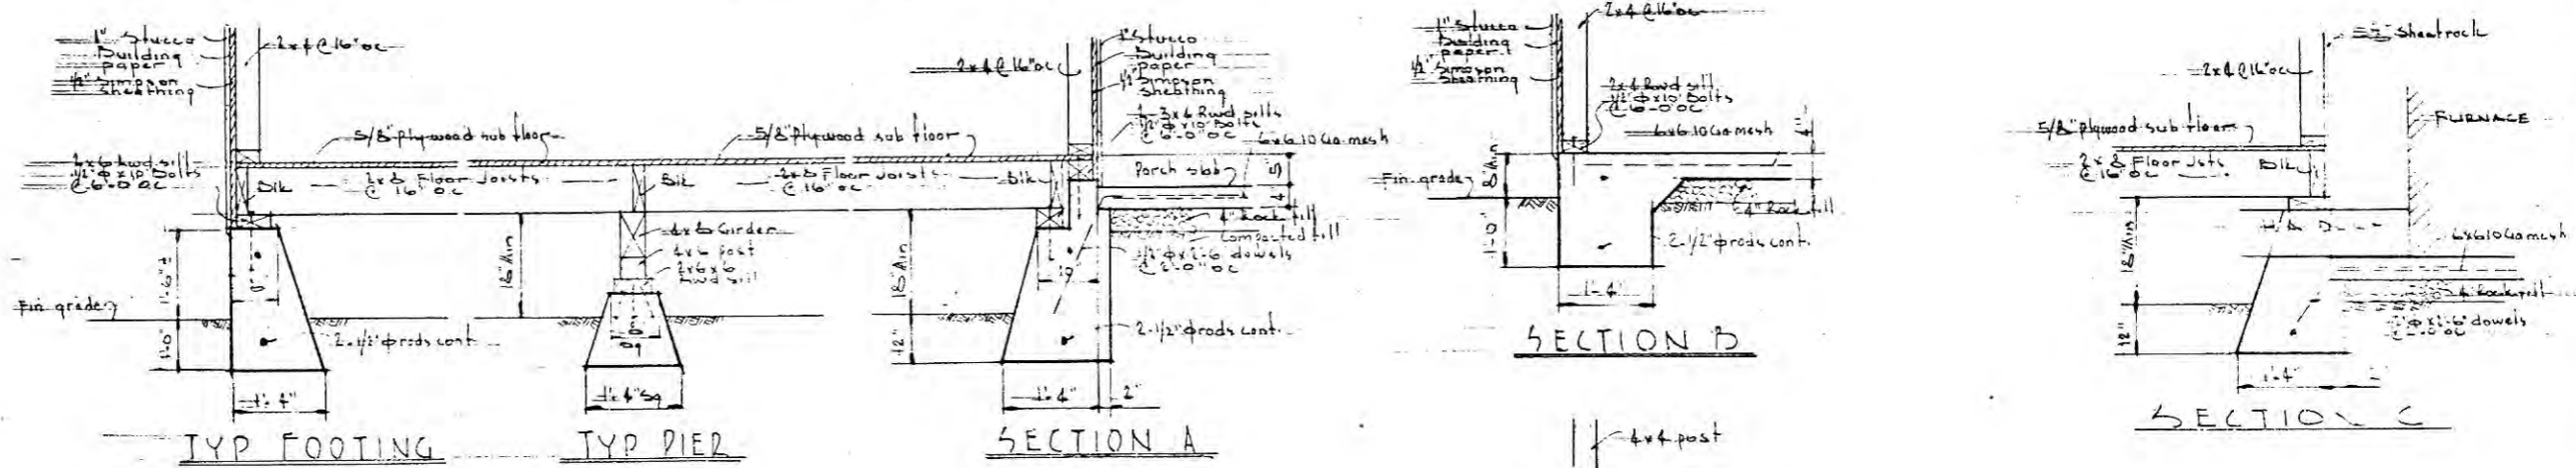
FOUNDATION DETAILS
Scale: 3/4" = 1'-0"

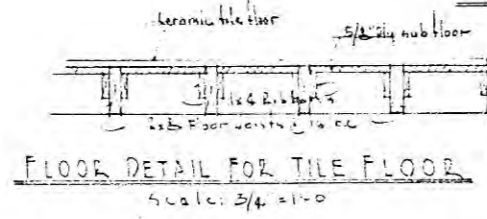
FLOOR DETAIL FOR TILE FLOOR
Scale: 3/4" = 1'-0"

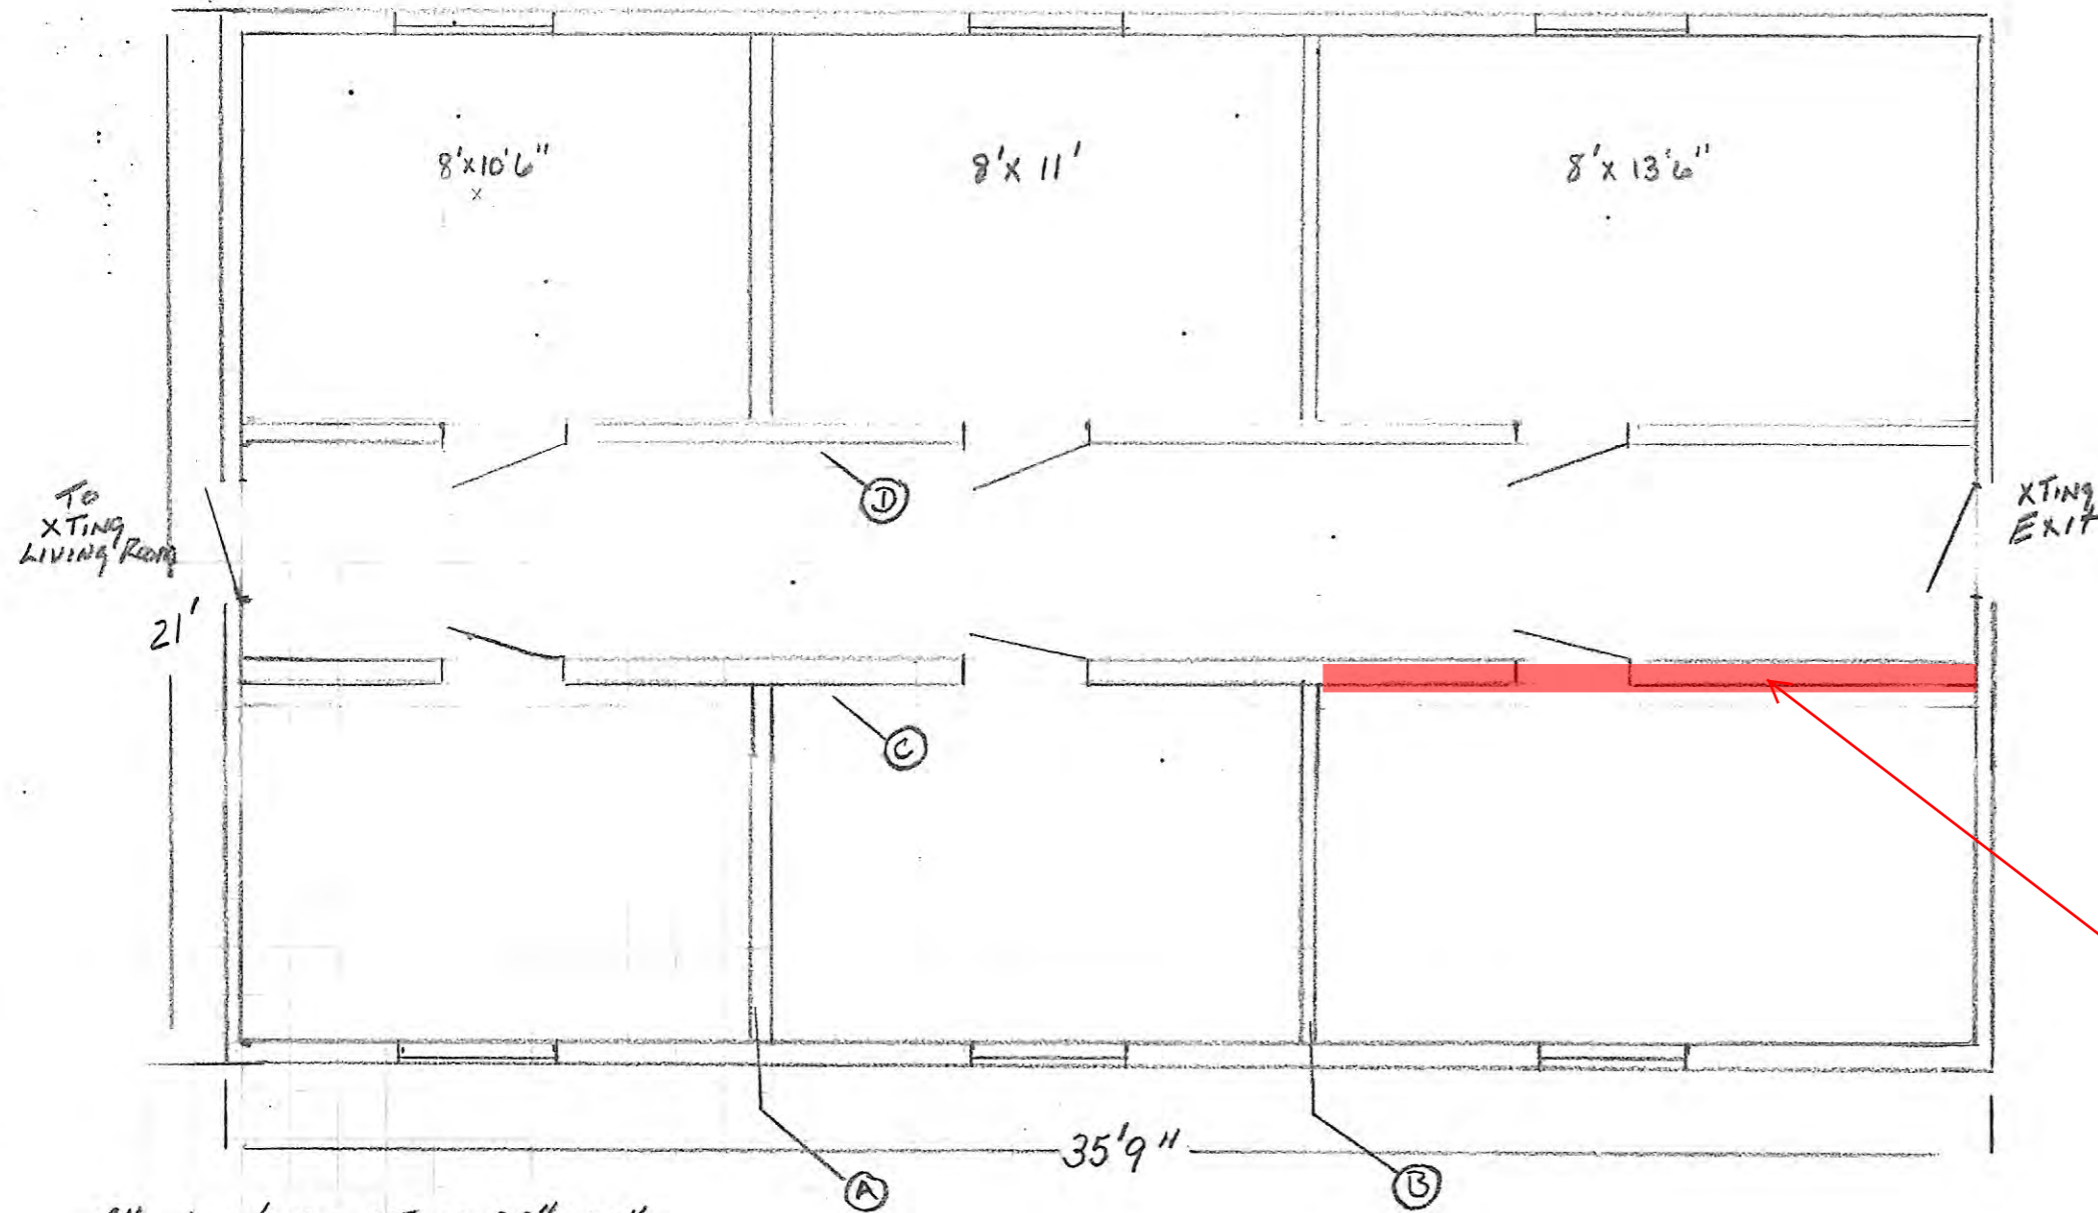
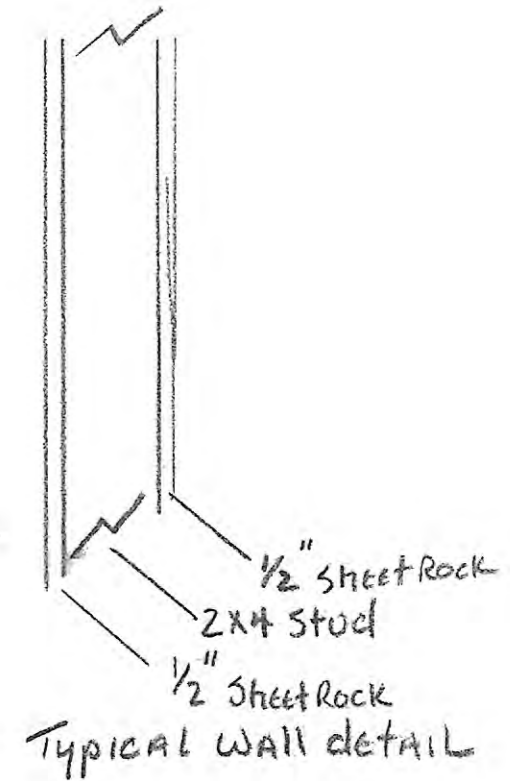
This wall was not built.
Confirmed on 11/20/13.
Note:
"xting" means "Existing Condition"

All windows xting 30"x38"
All doors 30" Hollow Core
All walls insulated for sound resistance
