County of San Mateo Planning & Building Department Agricultural Advisory Committee

SUBJECT: Consideration of Local Coastal Program amendment to facilitate future construction of a replacement fire station (County Fire Station Number 59) and extension of CSA-11 to serve the fire station and Pescadero Middle/High School located at 350-360 Butano Cut Off. Both projects are located in the Pescadero area of the unincorporated San Mateo County.

The County of San Mateo proposes to amend the San Mateo County Local Coastal Program (LCP) to facilitate construction of a replacement County Fire Station (Station No.59 in Pescadero), partial demolition and remodel of the existing fire station at 1200 Pescadero Creek Road for use during emergencies, and CSA-11 (County Service Area 11) water line extension to serve the replacement fire station and the existing Pescadero Middle/High School located at 350-360 Butano Cut Off. The project is limited in scope for these critical facilities to continue to serve the surrounding south coast area and are not otherwise growth inducing.

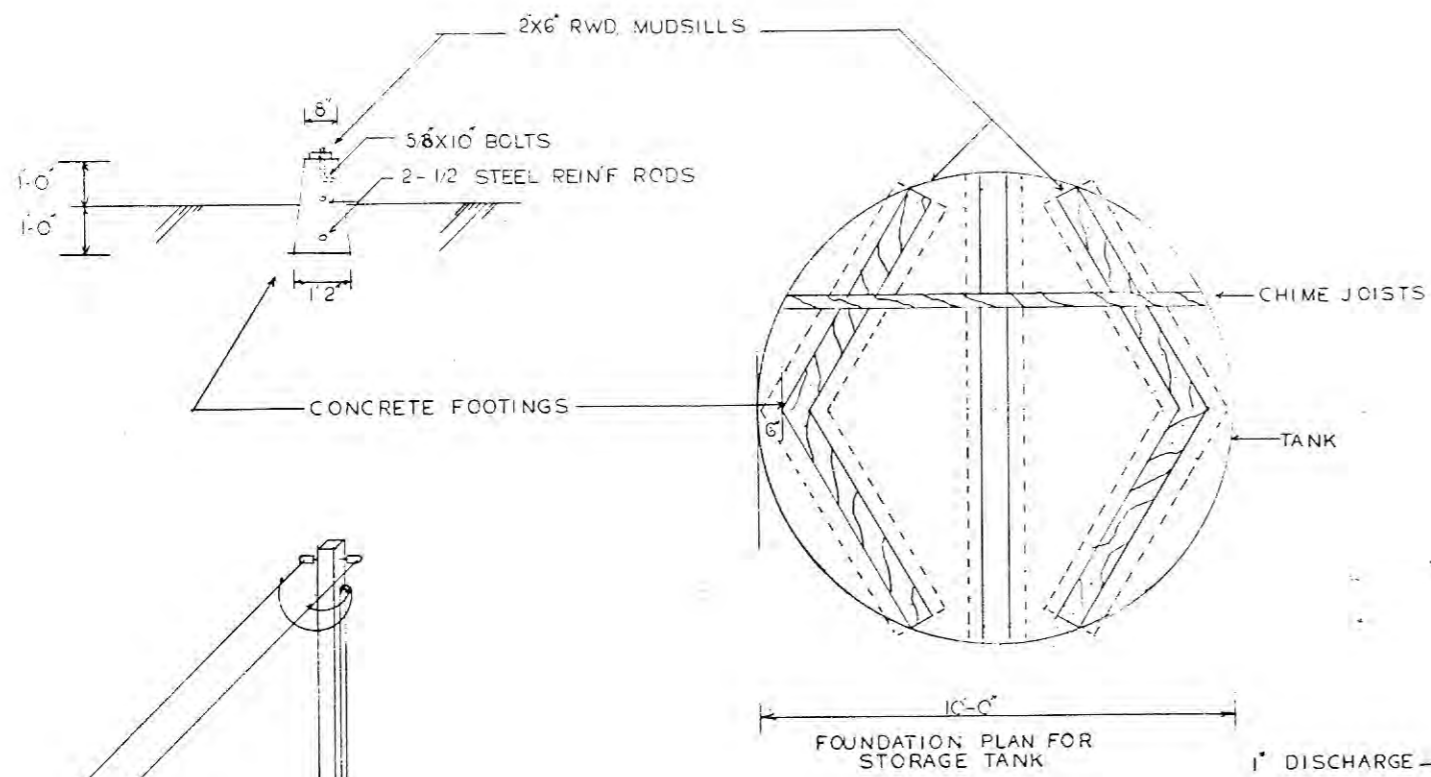
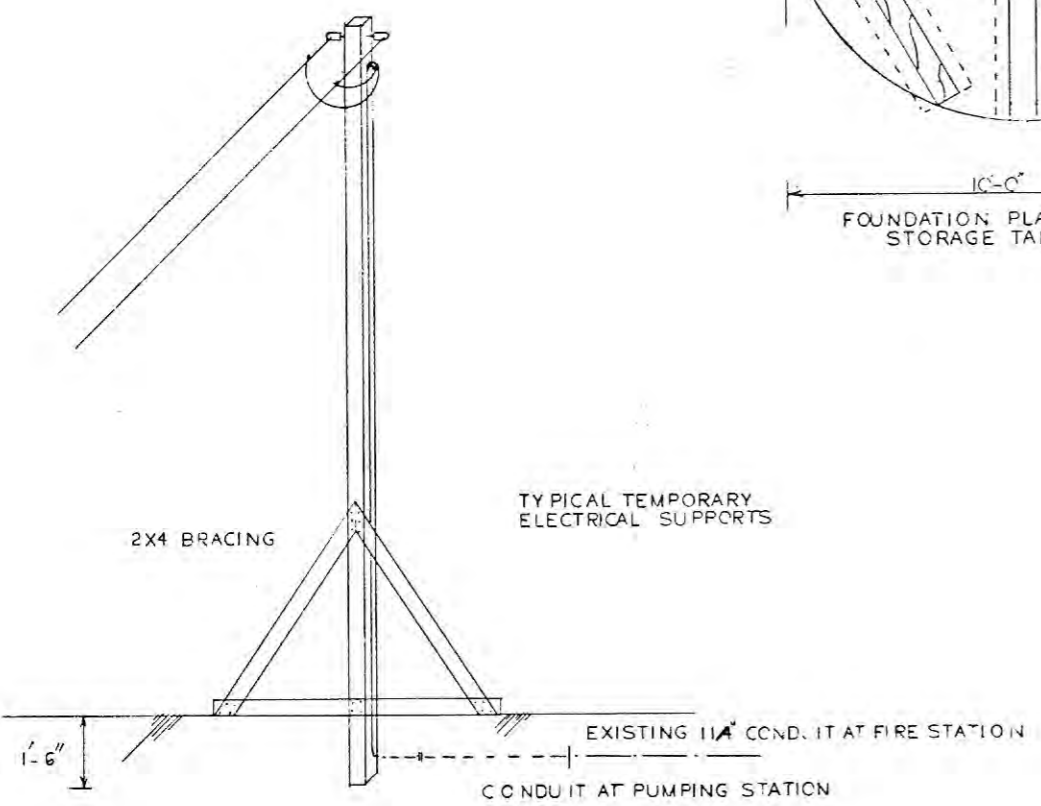
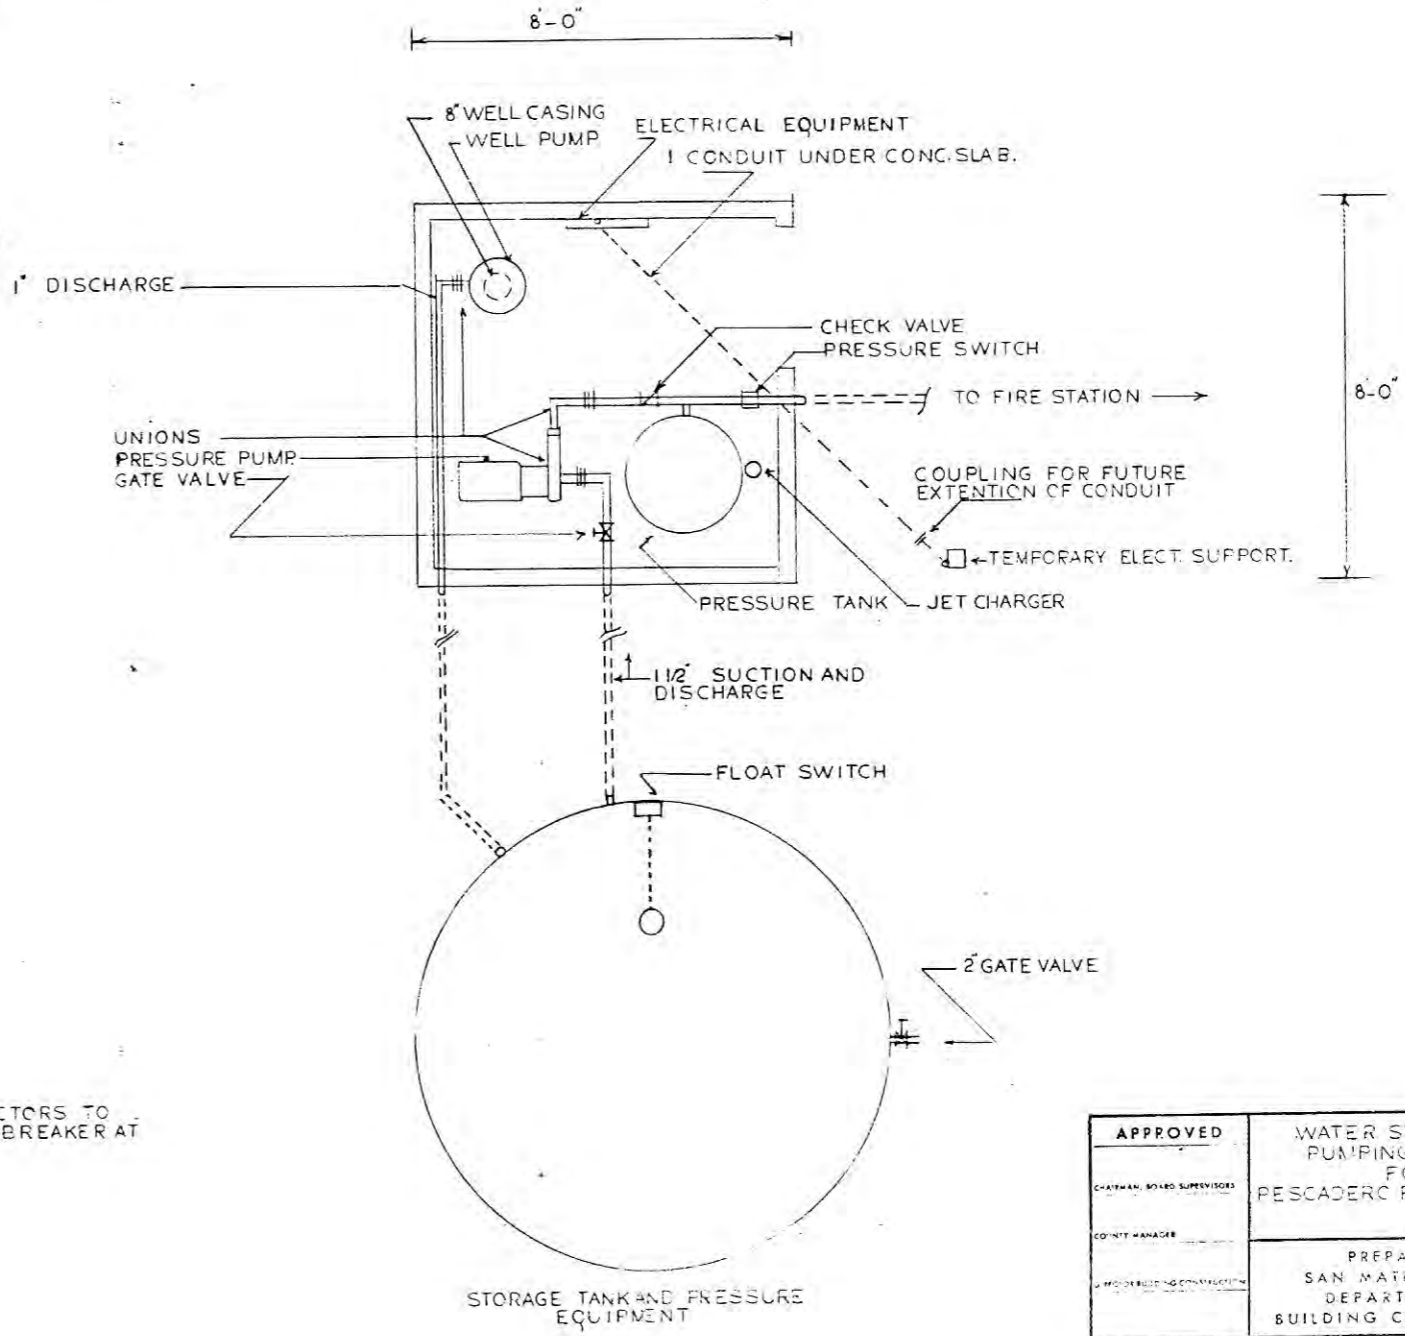
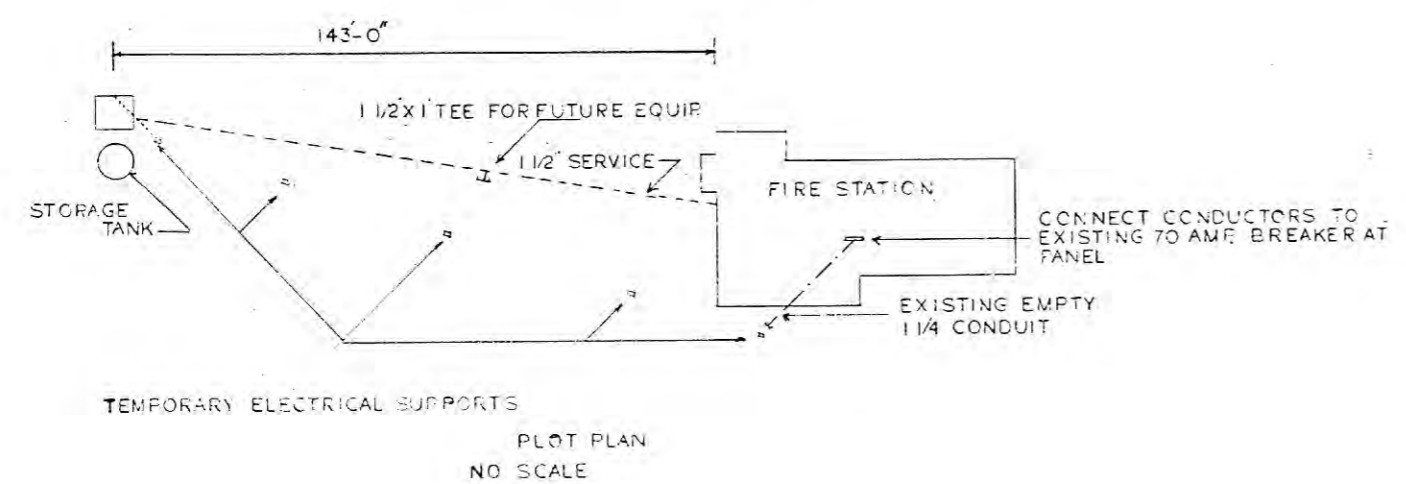
| APPROVED | WATER STORAGE AND PUMPING SYSTEM FOR PESCADERO FIRE STATION | DATE 6-28-57 |

- 1-CONCRETE FOUNDATION FOR STORAGE TANK BY OTHERS
- 2-PUMPING STRUCTURE AND CONCRETE FLOOR BY OTHERS
- 3-ALL PIPING BELOW GRADE SHALL BE INSTALLED AT A DEPTH OF 1'-0" MIN.

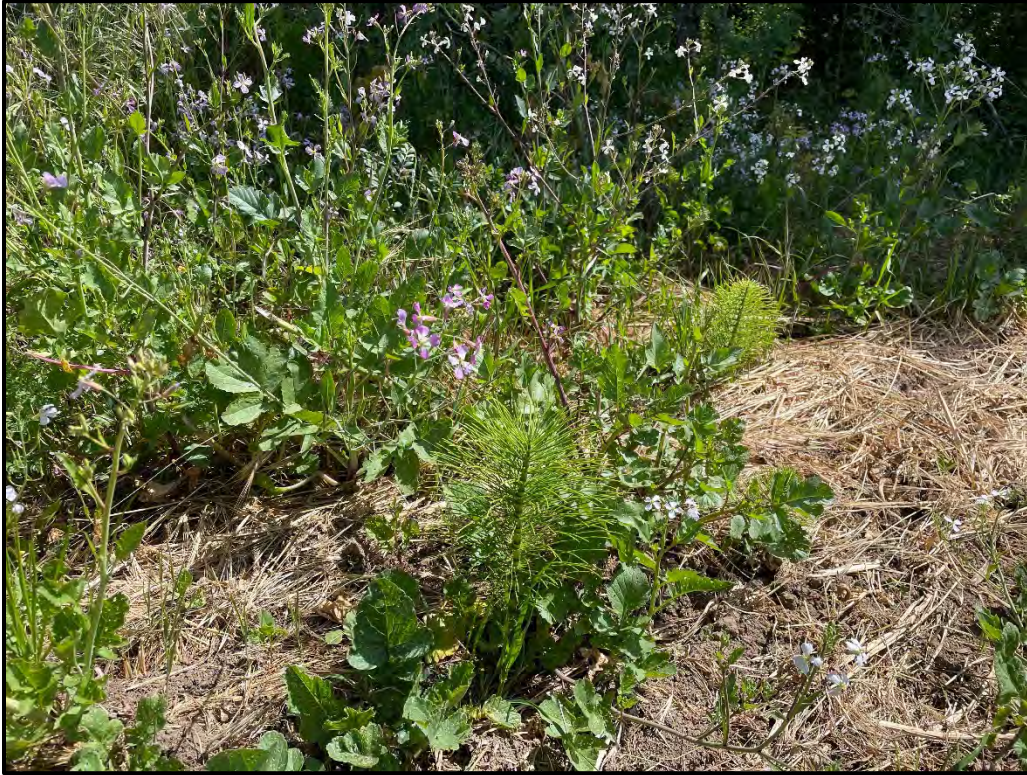
Giant horsetail growing among upland plant species, in an upland area outside of the Pescadero Creek riparian corridor. This photo was taken in an area that was not subject to recent soil/veg disturbance, and may represent mesic, but not wetland, conditions. Equisetum species are known to colonize disturbed areas and may be weedy, indicating that it may not be the best indicator for wetland, particularly if it's the only wetland species occurring.
